Sunwater Limited
Paradise Dam Safety Improvement Project
Technical Review Panel Report No 2

Technical Review Panel

Date **23 September 2019**
Status **Final**

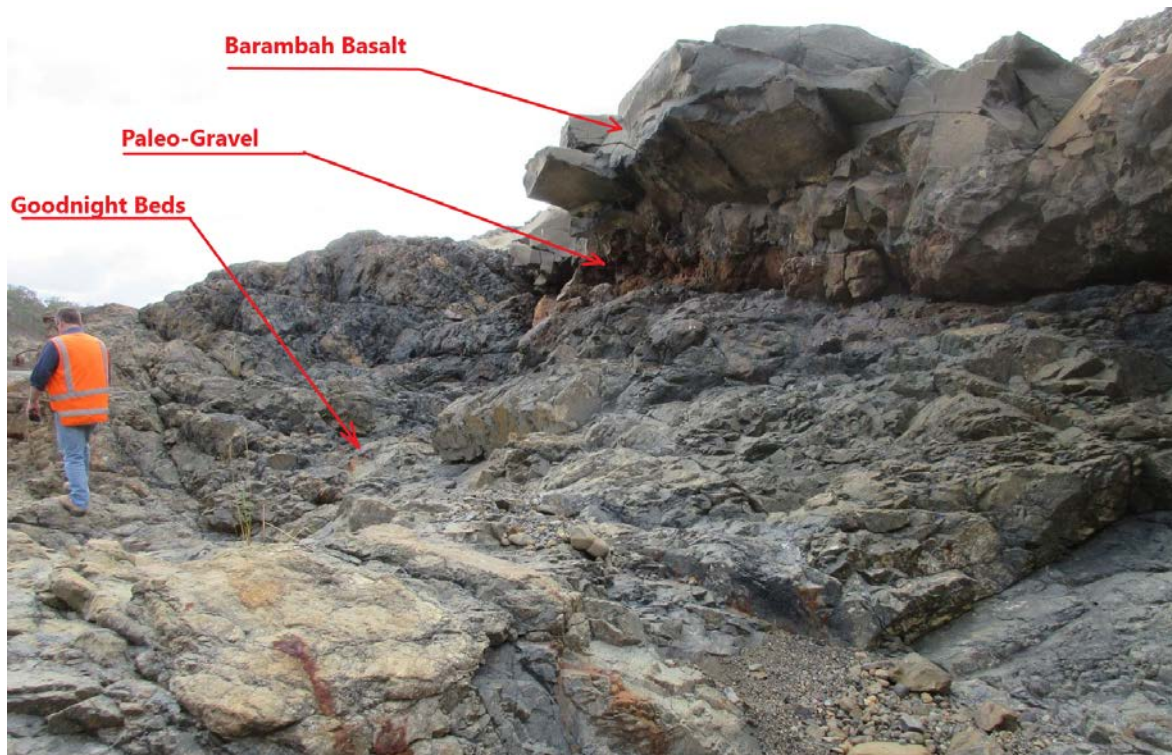
The principal bedrock units that affect the dam foundation stability are shown in Photo 2.1 and described as follows:

Photo 2.1: Bedrock outcrop on the right side of the river showing three of the primary geological units. A basalt bed is shown at the top of the outcrop. This underlain by the rusty colored, 20 to 30 cm thick paleo-gravel. The Goodnight Beds, with their chaotic fracture patterns, are visible at the base of the outcrop. Despite the variable fracturing of these beds are sound with fair resistance to erosion. Note the curved, sub-horizontal to gently inclined, en-echelon joints in the Goodnight Beds.

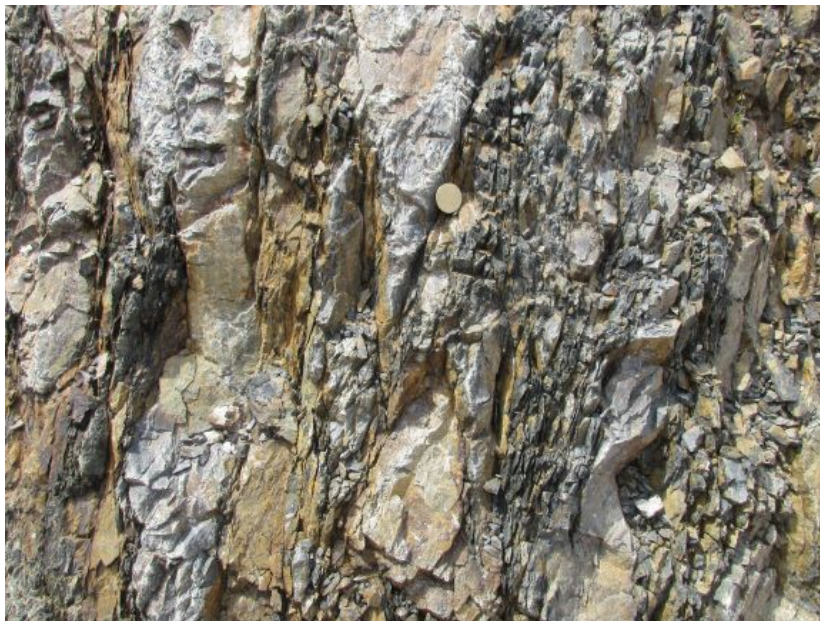
Photo 2.2: Variably sheared meta-arenite and meta-siltstone in the left bank near the Paradise Fault. Shear foliated dark grey carbonaceous meta-siltstone is interlayered with 10 to 20 cm wide nodules and layers of light-colored meta-arenite.

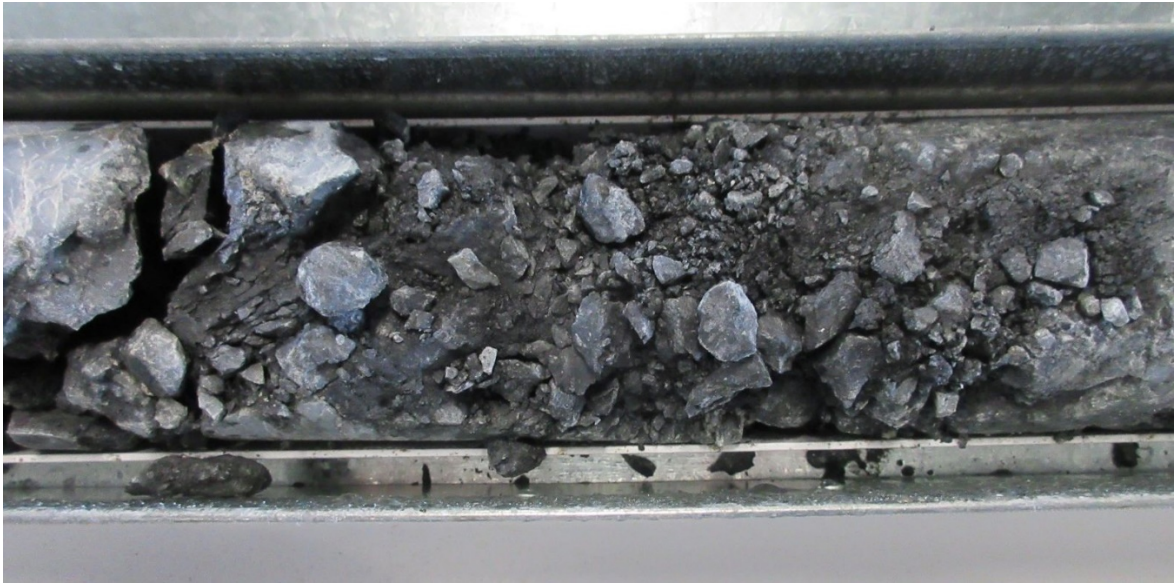
- a. **Sand/gravel sized fault gouge:** As shown on Photo 2.3, this consist of completely sheared/crushed material which has cohesionless, granular behaviour. Shear strength of this material should be evaluated by soil mechanics criteria.

Photo 2.3: Borehole PD-01. Typical sandy gouge with gravel size fragments

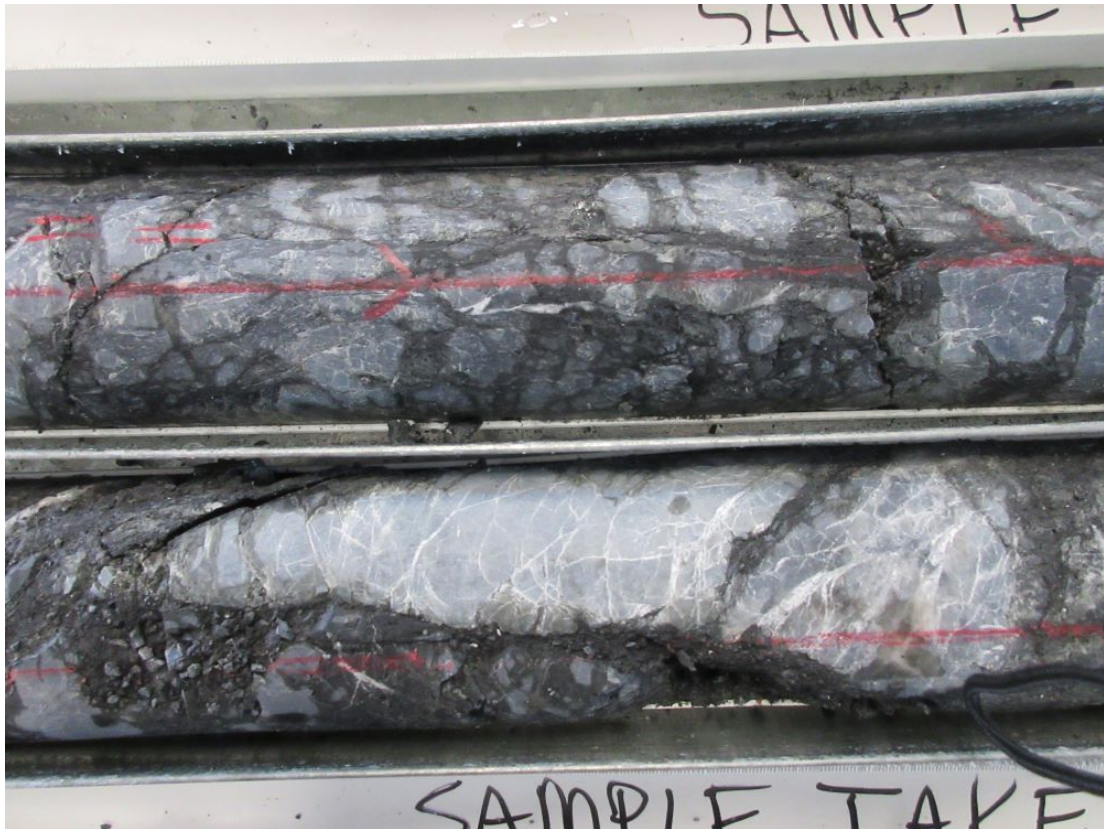
- b. **Weakly to moderately strongly healed breccia:** Photo 2.4 shows weakly healed breccia. Fracture infilling consist of silica and silt material which is porous and v weak. Samples are delicate and can shatter into breccia fragments when handled. This material usually cannot be accurately tested by an unconfined compressive strength (UCS) test. Testing can be done only when there is good sample confinement for the weakly bonded fractures. Carefully executed triaxial tests can give a representative strength envelope.

Photo 2.4: Borehole PD-01: Weakly healed breccia. Fracture infilling consist of silica and silt material. is porous and very weak. Sample breaks in breccia fragments when handled

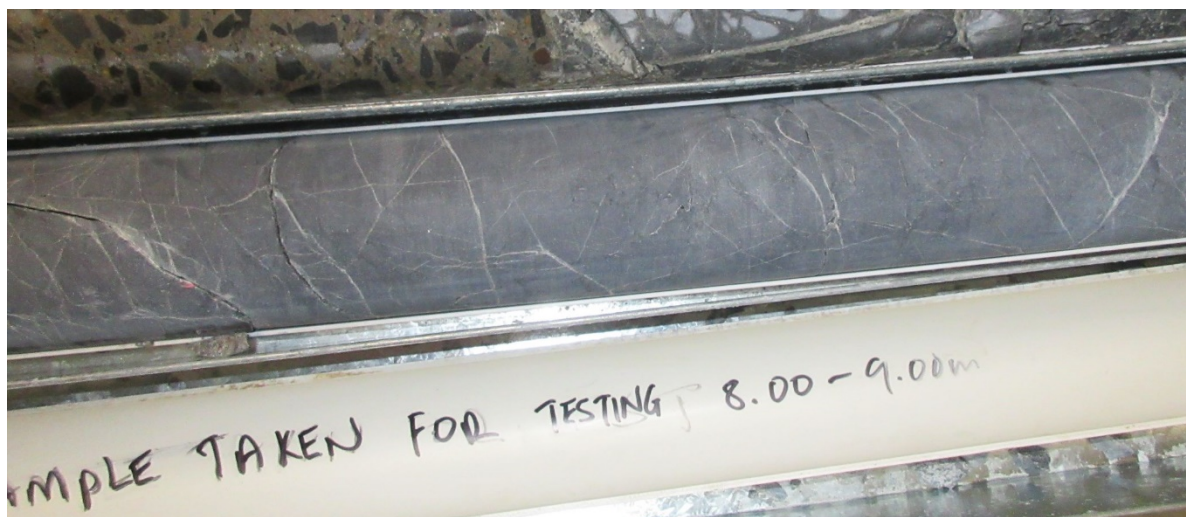
- c. **Strongly healed broken rock:** Photo 2.5 shows a healed fractured rock that is held together by strong silica veinlets. Generally, this category of rock can be tested by conventional unconfined compressive strength tests. Strongly bonded veinlets should not be counted as fractures when doing RQD assessments.

Photo 2.5: Borehole PD-01: Moderately to strongly healed meta breccia. Fractures are healed with silica veinlets.

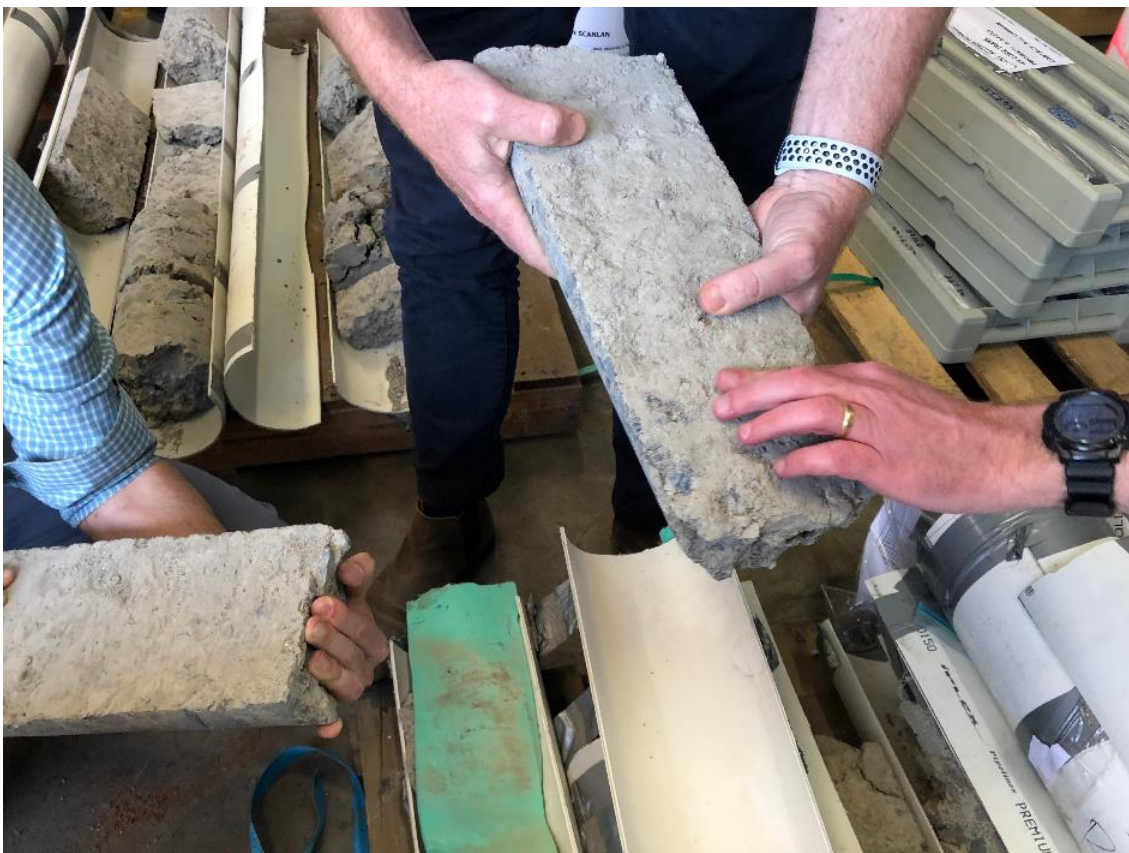
The TRP had the opportunity to visit the Trilabs laboratory and see samples from the direct shear testing and the horizontal core. Photo 1 below shows an example of an unbonded joint surface.

Photo 1 Unbonded RCC Lift Surface

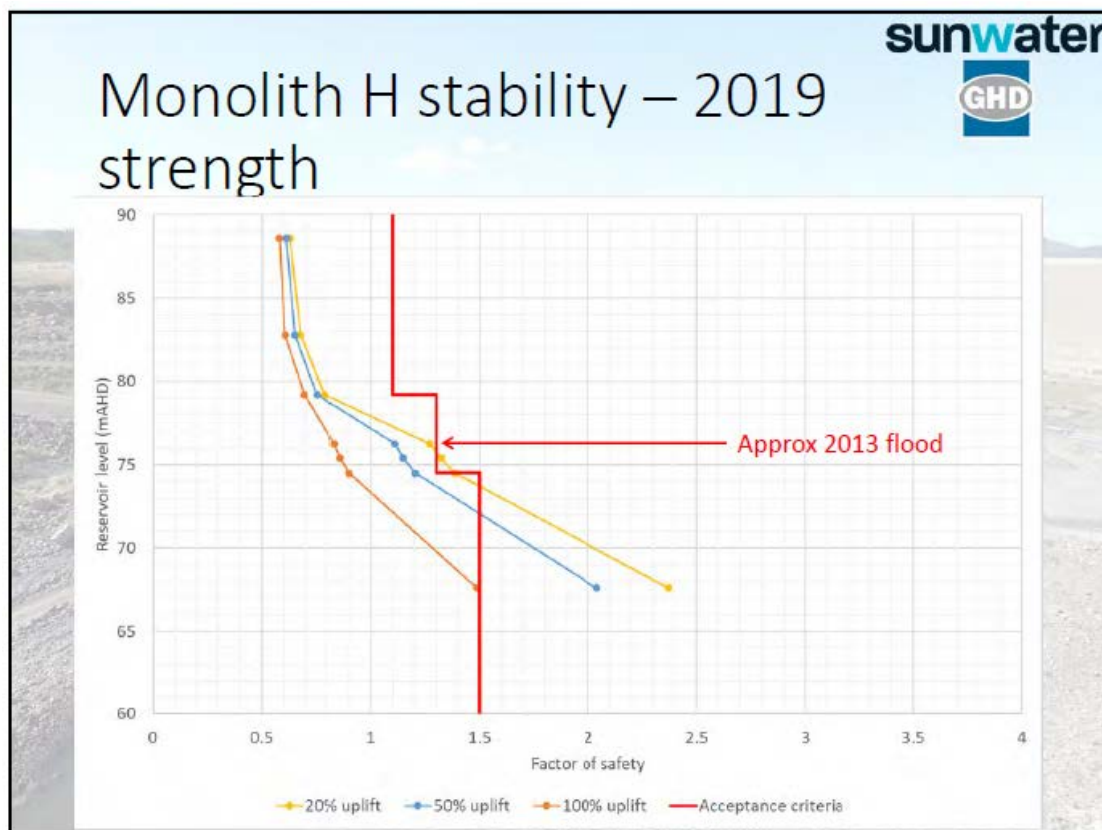
Fig 1 Stability Summary

On the basis of GHD’s analysis results using the frictional strength of 39.3° presented in Fig 1 above the TRP notes:

The TRP requests that the extent of any base cracking that occurs in the above analysis is also noted in the stability output, along with the normal stress at the downstream toe.

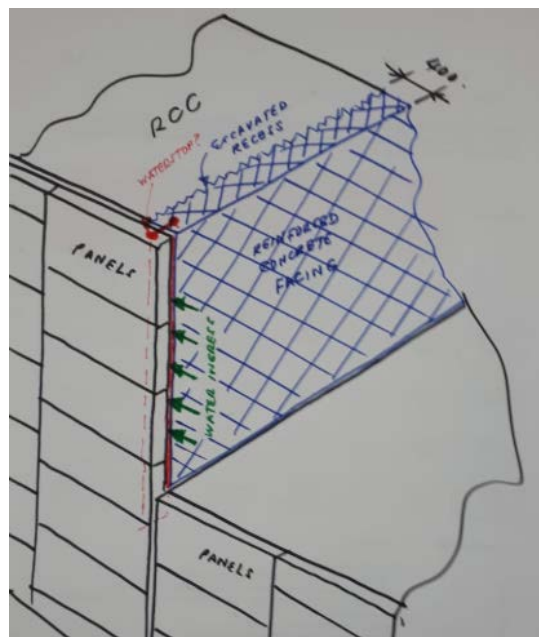
An important detail has not been considered (or has not been finalised) as part of the interim lowering. The vertical 400 mm recess on the sides of the demolished ogee, which is to be reconstructed with a reinforced concrete (RC) facing, will be located downstream of the existing face panels. However, the elaborated waterstop arrangement presented do not include vertical waterstops to prevent ingress of water at the interface between the new reinforced concrete facing, the Carpi membrane and the upstream panels. Ingress of water on this interface must be prevented (possibly using a vertical waterstop between the upstream panels and the new RC facing) as such ingress could lead to pressurisation and potential popping-up of the panels, with the subsequent loss of uplift reduction that is crucial to the stability of the dam.
