**Paradise Dam
Lungfish and Aquatic Ecosystem Monitoring
2006-2016
Biennial Summary Report 5 and Final Report**

**Prepared for Burnett Water Pty Ltd
June 2016, Revised October 2017**

Final Report, Prepared for Burnett Water

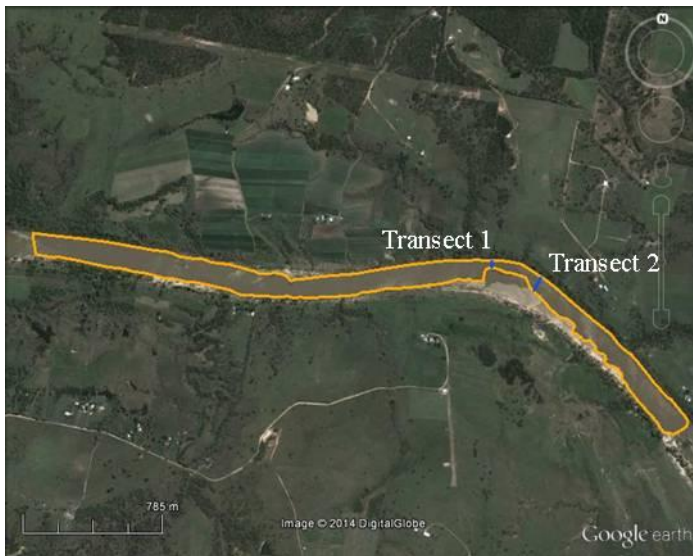
Figure 2.2 – Isis sampling area (orange outline) and habitat transects (blue)

The Isis sampling site (the downstream reference site) was situated in flowing river reaches downstream of the Ned Churchward Weir. Flow and river height in this area are influenced by water releases from the weir. The primary sampling area was accessed via a private property off Pine Creek Road approximately 10.5 km downstream of the weir. From this point upstream pools and runs were accessed as far as water levels allowed (refer Figure 2.2). In winter 2007, extremely low water levels necessitated use of an alternative access point approximately 5km downstream, at the SunWater Don Beattie Pump Station. A third alternative access point was utilised in summer 2011 due to flood damage at other locations.

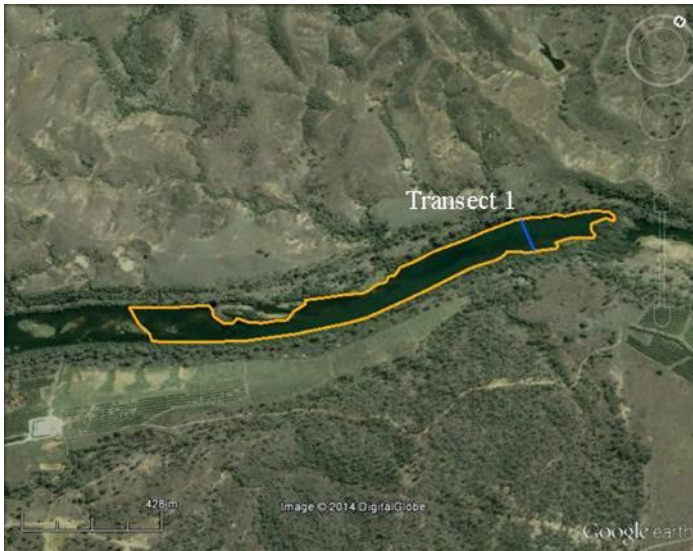
Figure 2.3 – Figtree sampling area (orange outline) and transect (blue)

The Figtree site originally comprised two pools located approximately 3km downstream of the Paradise Dam. The pools were accessed via separate access points on private property along Cherelly Orchard Road. Flow and river height in this area are influenced by releases from the Paradise Dam. The downstream pool was rarely accessible. The available area for sampling was determined by water levels over large submerged rocks within both pools. In summer 2009/10, a major flow event blocked vehicular access to this site and delayed sampling. The pool was eventually accessed by launching further upstream and using elevated flows to access the area by boat. From 2013 onwards, the site was accessed from a private property on the northern bank after floods caused extensive damage to banks at the original launch location.

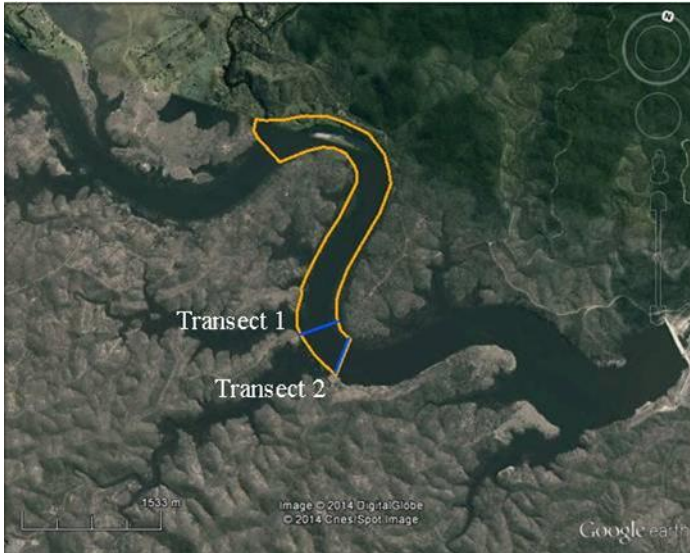
Figure 2.4 – Kalliwa Hut sampling area (orange outline) and transects (blue)

The Kalliwa Hut site was located within the Paradise Dam impoundment adjacent to the former Kalliwa Campground. The site was accessed by boating upstream from the Paradise Dam public boat ramp. Sampling was conducted upstream and downstream from the Kalliwa Hut targeting the shoreline and submerged vegetation within the impoundment (refer Figure 2.4).

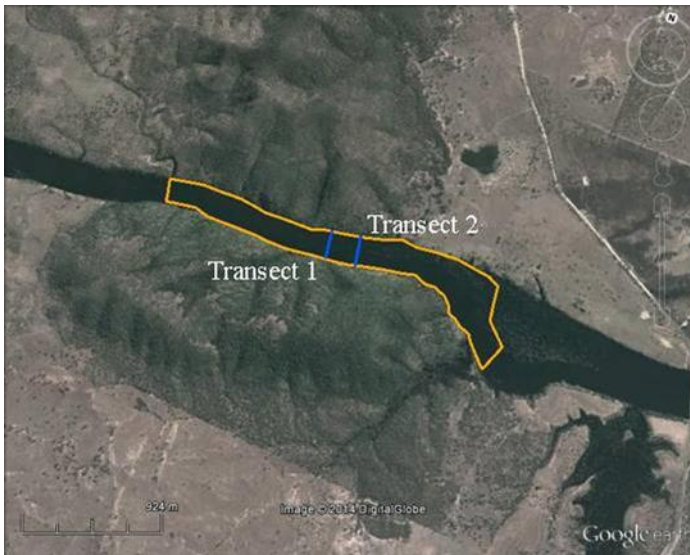
Figure 2.5 – Mingo Gorge sampling area (orange outline) and transects (blue)

The Mingo Gorge site was located within the upper reaches of the Paradise Dam impoundment, approximately 1km upstream of the Mingo Crossing Bridge. The original access points were located on private property off the Gayndah / Mt Perry Rd or at the camping area. Subsequently, the site was accessed from the Mingo Crossing Bridge public boat ramp. Sampling effort was concentrated upstream of the launch site in a deep pool and a series of rocky glides within the gorge area (refer Figure 2.5). Heavy infestations of floating aquatic weeds prevented access to this area in winter 2007. In this instance, an alternative sampling location was established at the Mingo Crossing Bridge where the infestation was less dense.

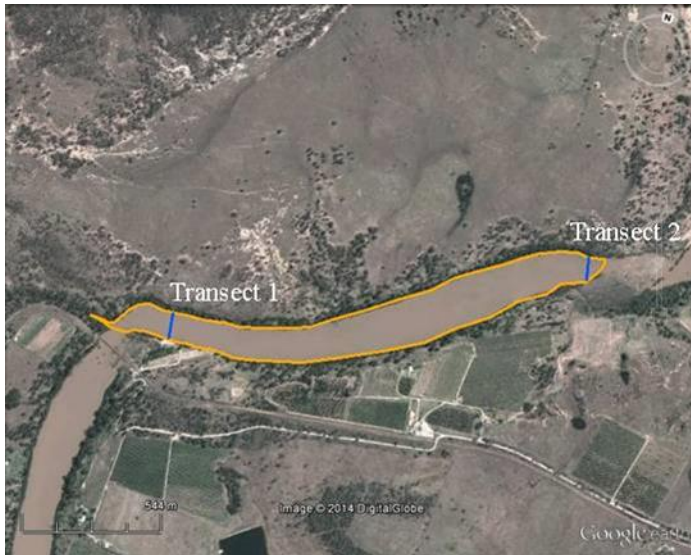
Figure 2.6 – Gray's Waterhole sampling area (orange outline) and transects (blue)

Gray's Waterhole is a large permanent pool on the Burnett River at Mt Lawless, approximately 19km downstream of Gayndah. The site was accessed via private property off Gray's Road downstream of a railway crossing across the river. Sampling generally occurred throughout the pool and extended a short distance into a tributary creek (refer Figure 2.6).

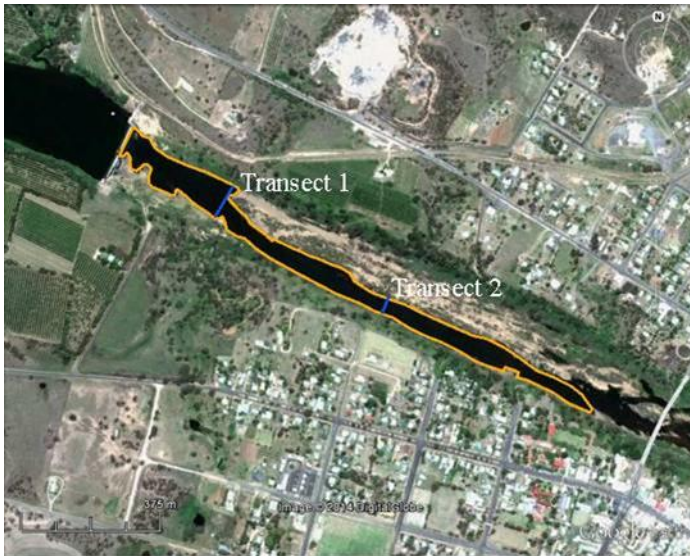
Figure 2.7 – Claude Wharton Weir sampling area (orange outline) and transects (blue)

This site included the tail water pool of Claude Wharton Weir and an adjacent pool downstream. The pools became connected during flow events in 2011. Water flow in the area is influenced by releases from the weir. The original access points were located on the northern bank via tracks off the Burnett Highway or the southern bank on tracks near the weir wall. An alternative access point was established through SunWater's Claude Wharton downstream access track following flooding in 2011. During the first two years of sampling Claude Wharton Weir did not have an operating fishway. The fishway has been operating intermittently for the last six years (refer Figure 2.7).

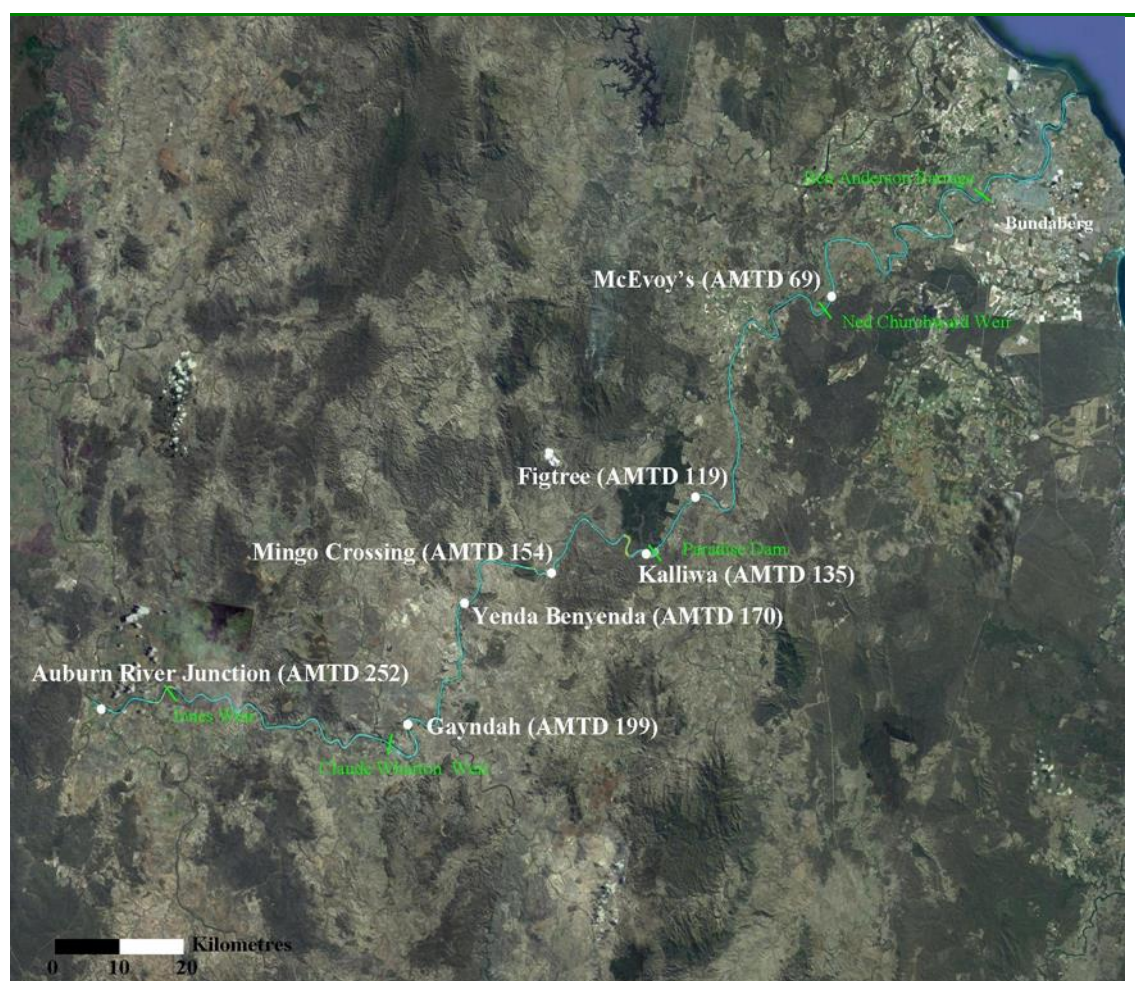
Figure 2.9 – Map of the Burnett River (blue line) indicating the lungfish spawning survey sites (white dots).

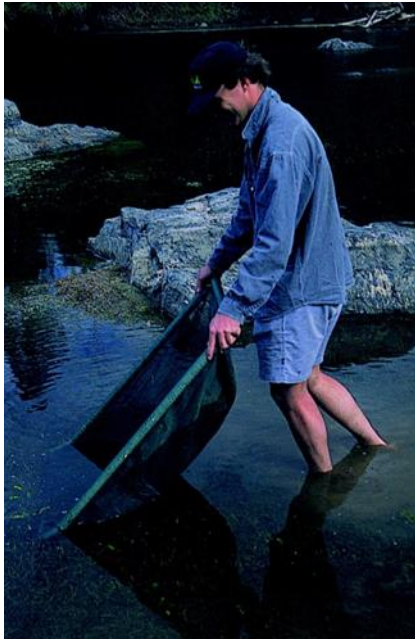
Figure 2.10 – Using a push net to collect lungfish eggs

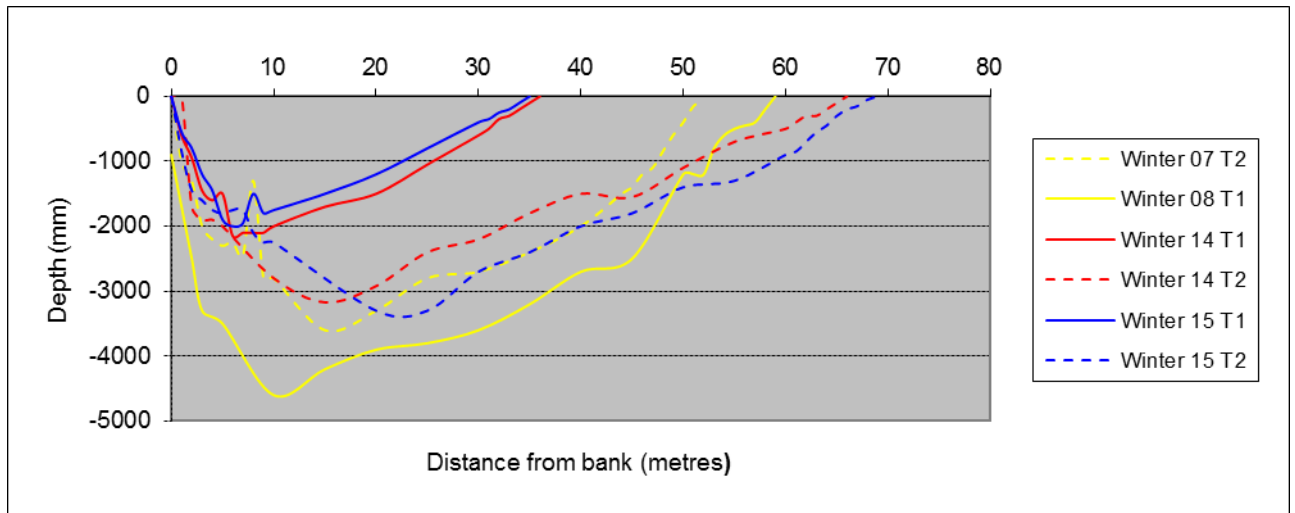
Figure 3.8 – Depth profiles of Site 1 (Isis)

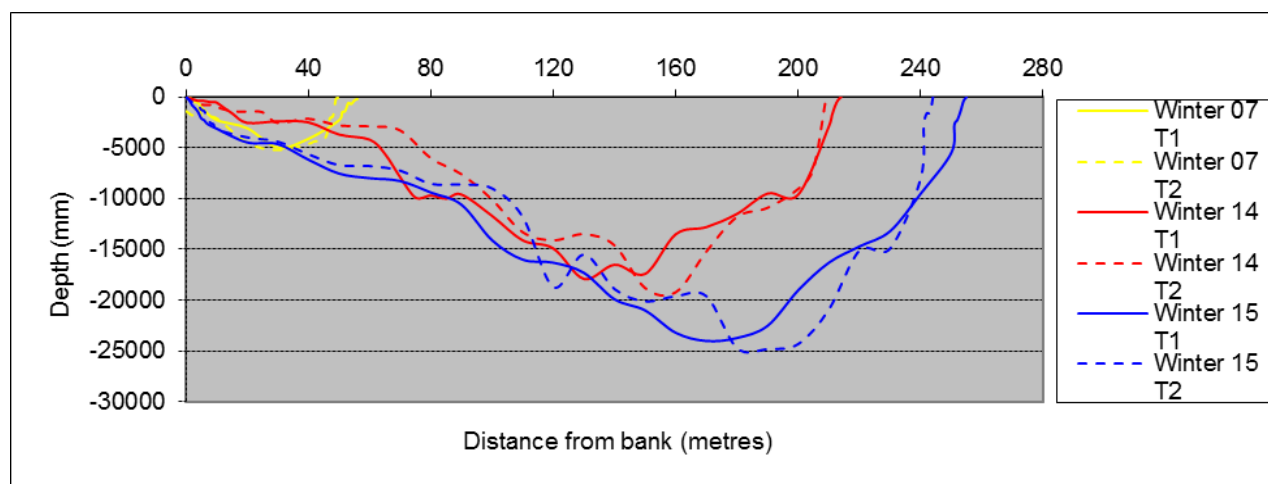
Figure 3.11 – Depth profiles of Site 5 (Mingo Gorge)

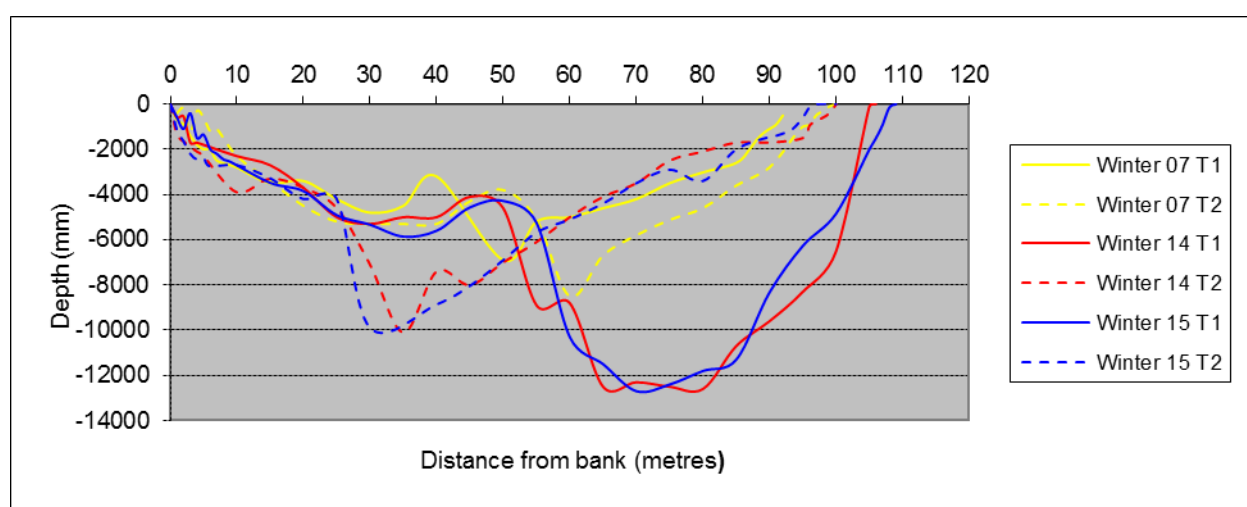
Figure 3.12 – Depth profiles of Site 6 (Gray’s Waterhole)

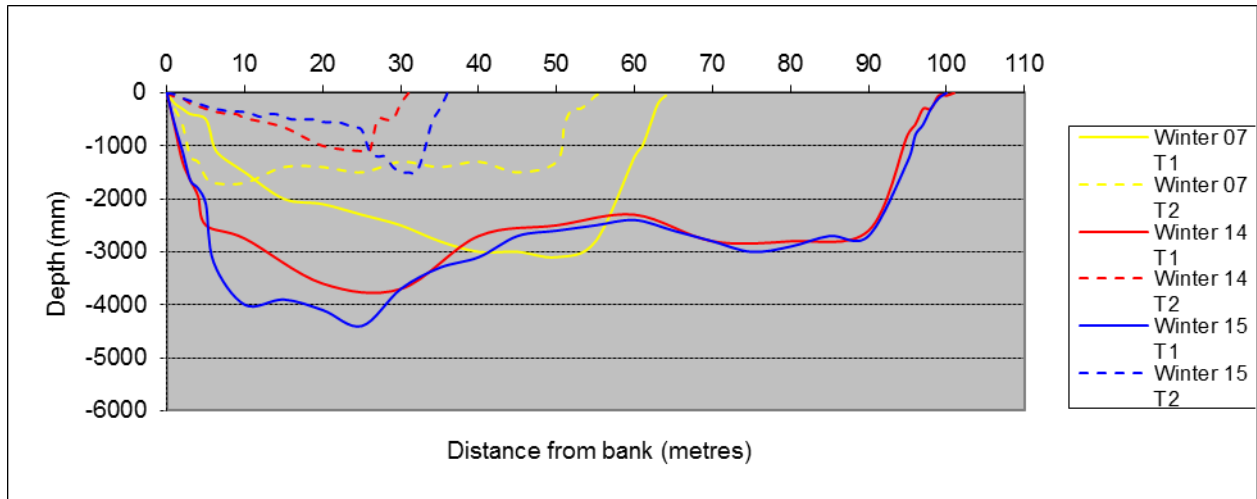
Figure 3.13 – Depth profiles of Site 7 (Claude Wharton Weir)

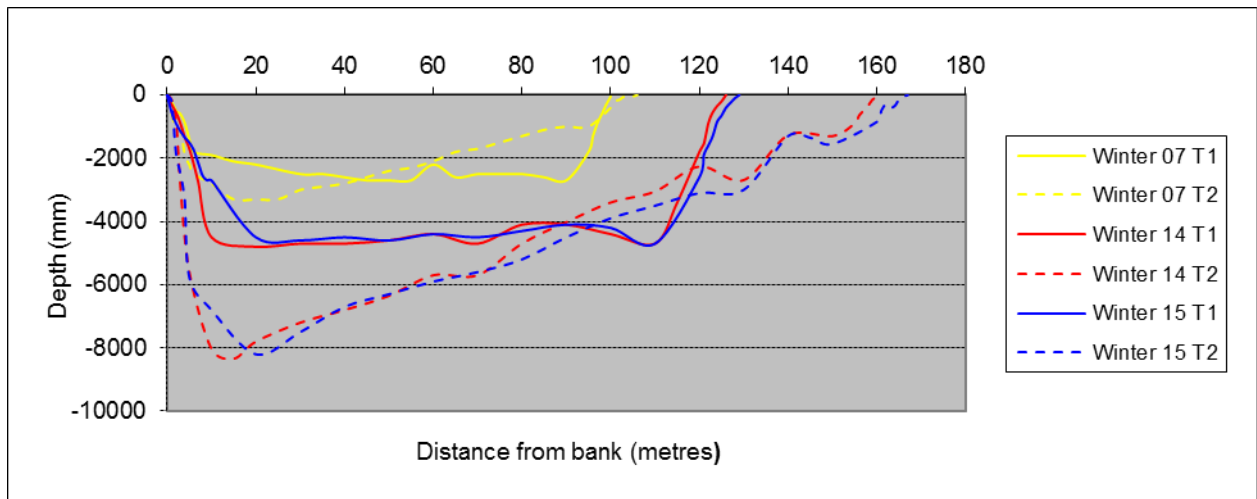
Figure 3.14 – Depth profiles of Site 8 (Mundubbera)

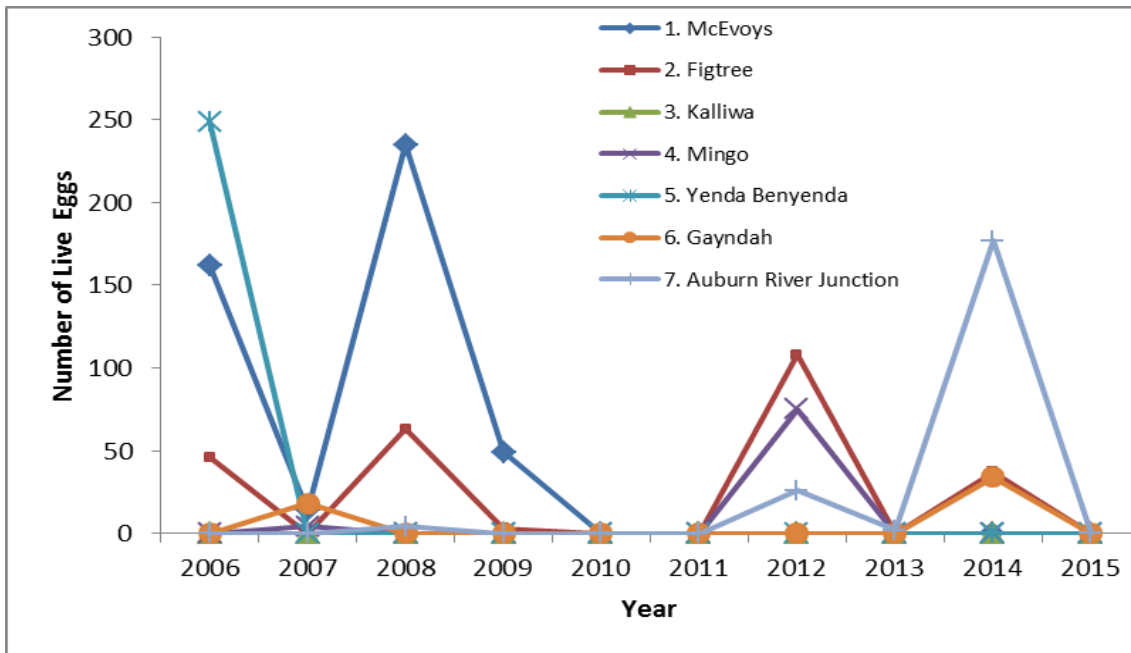
Figure 3.15 – Lungfish egg numbers observed by site and season

Lungfish eggs were located in each of the first four years of spawning surveys between August and November. No lungfish eggs were collected in the 2010, 2011 or 2015 spawning surveys. Eggs were collected in 2012, 2013 and 2014. During the survey period, some evidence of spawning activity was confirmed at six of the seven sites (Table 3.16, Figure 3.15). No eggs were collected from Spawning Site 3 (Kalliwa Hut/Paradise Dam boat ramp) within the impoundment. This site was shifted closer to the wall (near the boat ramp) when access to the original site was blocked during 2008 due to rising water levels. A total of 1967 lungfish eggs were collected from 11320 push net shots. Lungfish egg(s) were present in 372 (3.29%) of all push net shots. A total of 655 eggs were collected in 2006, 115 in 2007, 508 in 2008, 74 in 2009, 0 in 2010, 0 in 2011, 311 in 2012, 3 in 2013, 301 in 2014 and none in 2015.

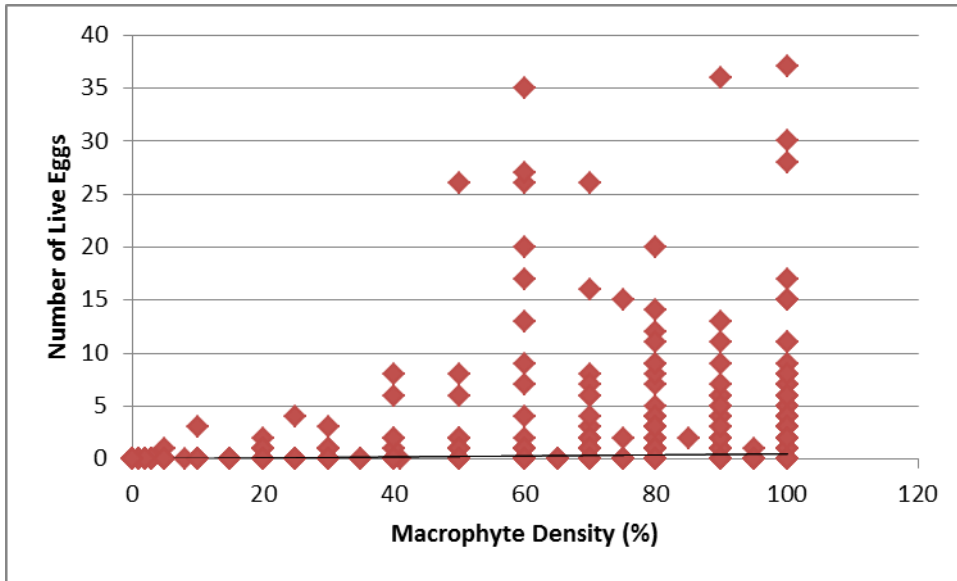
Figure 3.16 – Number of lungfish eggs in relation to macrophyte density

Approximately 86% of all eggs were located in depths less than 500mm and more than 99% of all lungfish eggs were collected from shots where macrophyte density exceeded 50% (Figure 3.16).+
