# Rookwood Weir

## Operations Phase - Annual Turtle Monitoring Report 2024-25

| <b>Project name</b> | | Rookwood Operational Phase Turtle Movement Study | | | | | |
|---|---|---|---|---|---|---|---|
| <b>Document title</b> | | Rookwood Weir Operations Phase - Annual Turtle Monitoring Report 2024-25 | | | | | |

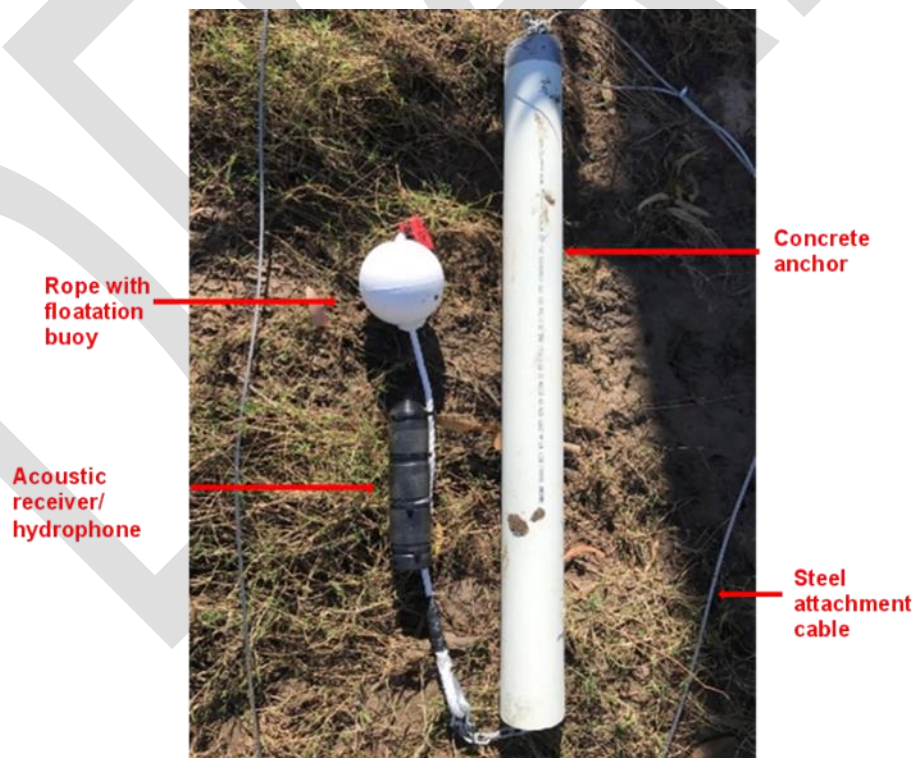
**Plate 2.6** Vemco VR2-W underwater acoustic hydrophone mounted to 12 mm rope with floatation buoy and steel attachment cable

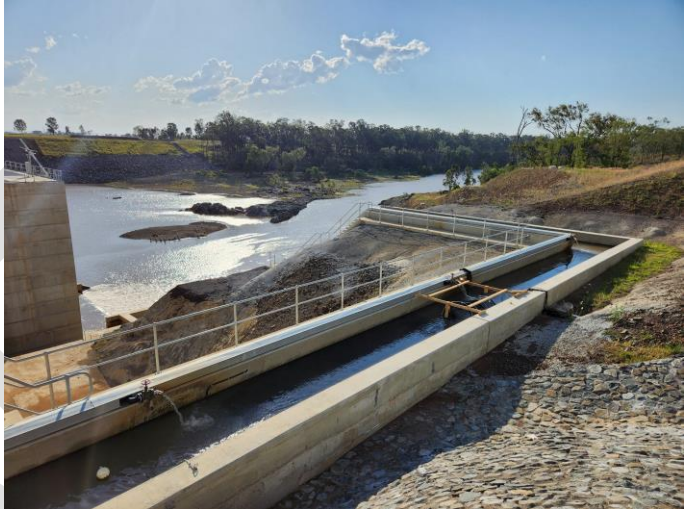
| Survey location | Habitat description | Photographs |
|---|---|---|
| Turtle passage and approach channels | <p>The turtle passage infrastructure at Rookwood Weir consists of a 172 m long by 2 m wide sloped turtle ramp with resting pools every 15 m. The entry and exit points of the turtle passage are located at the river margins where turtles can access them during low velocity conditions. A widened (6 m) funnel entrance/exit is provided both upstream and downstream to increase the area over which turtles can access the turtle passage at minimum headwater and tailwater conditions. The downstream entrance is immediately adjacent to the low flow outlet and fishway.</p> <p>The ramp varies in slope up to a maximum of 45 degrees and is textured with exposed aggregate to create a roughened surface for the turtles to grip. The entry and exits into each resting pool are sloped for easy turtle access. Resting pool shelters provide shade and protection within each resting pool.</p> <p>A small attraction flow is provided down the ramp and permanent water contained within the resting pools. Passive Integrated Transponder (PIT) tag readers are included at the entrance, middle and exit of the turtle passage to facilitate turtle monitoring.</p> <p>The approach channels (upstream and downstream) are within the Fitzroy River and are immediately upstream and downstream of the entrance ramps to the turtle passage.</p> | |

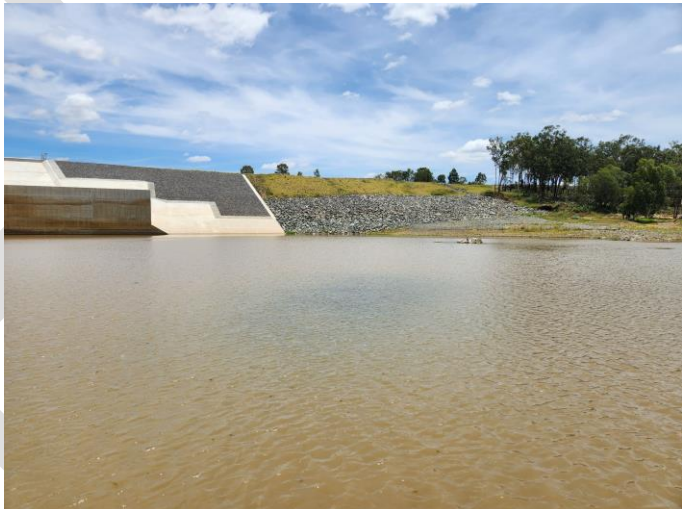
| Survey location | Habitat description | Photographs |
|---|---|---|
| Stilling basin and associated pool | <p>The stilling basin is at the base of Rookwood weir which is connected with the pool directly downstream of the weir. The pool extends from the stilling basin approximately 100 m downstream before connecting with the larger, deeper pool (Rookwood downstream pool). The channel is approximately 230 m at its' widest point and 10 m at its' narrowest (downstream) point which represents the approach channel for the turtle passage. This pool is approximately 5 m deep with flow velocity and water depth highly influenced by releases from the weir and uncontrolled spilling events. There is a large, high quality sand bank on the left bank with slumping of the earthen upper bank. Substrate consists of a mix of bedrock, gravel and sand. There is extensive aquatic weed, water lettuce (<i>Pistia stratiotes</i>), which is being transported downstream from the weir pool in autumn 2025 when the weir was overtopping.</p> | |

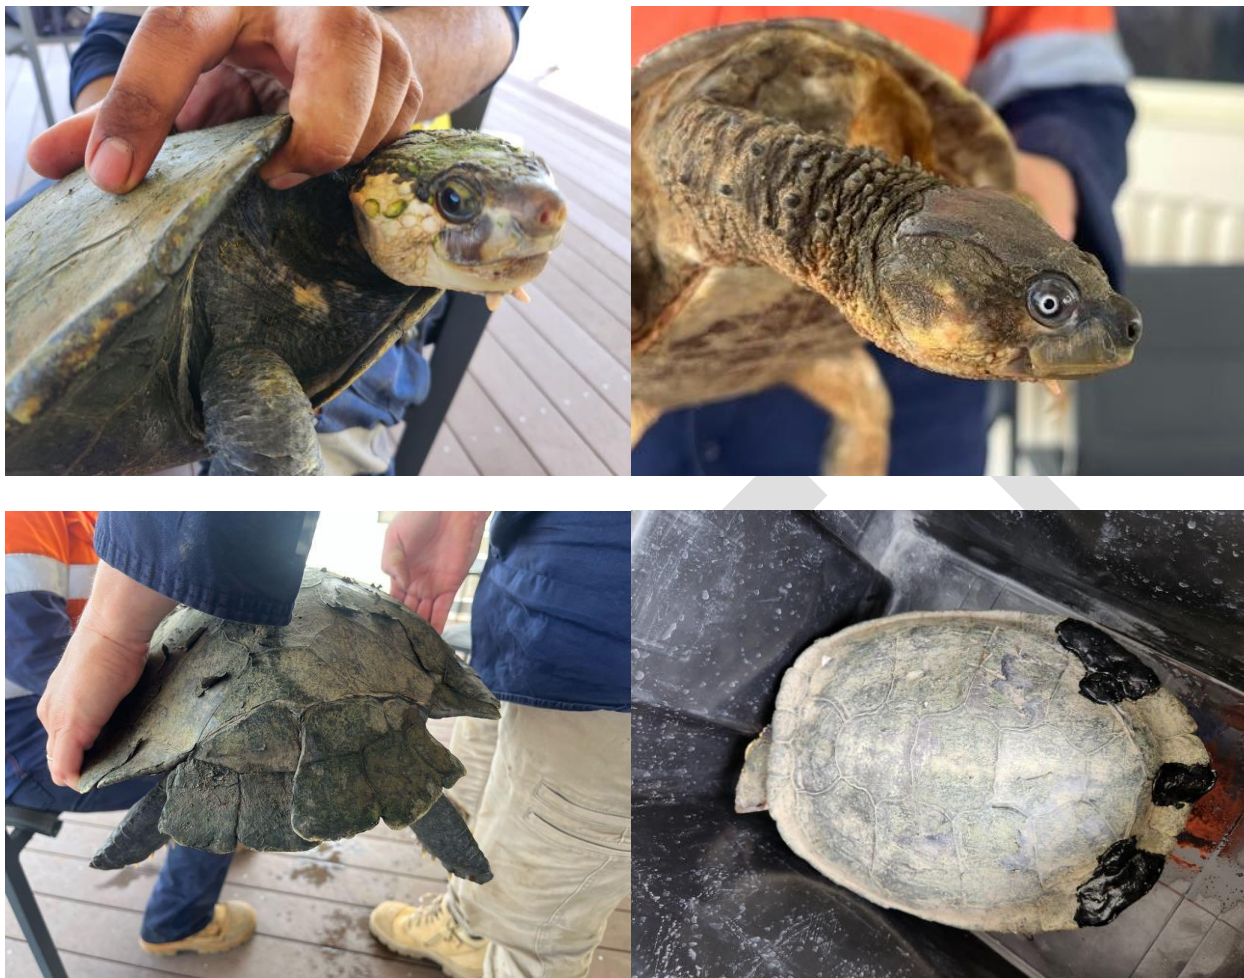
**Plate 3.4** *White-throated snapping turtle (top left); Fitzroy River turtle (top right) caught during October/November 2024 turtle capture surveys, and damaged carapace of a white-throated snapping turtle (bottom left); with carapace stabilised by epoxy (bottom right).*

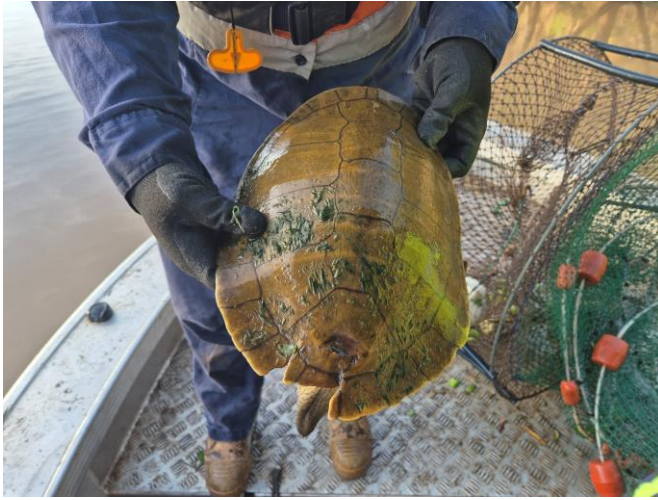
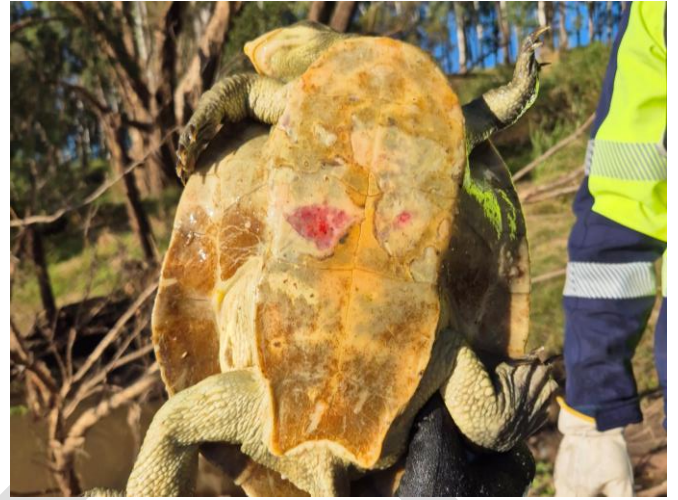
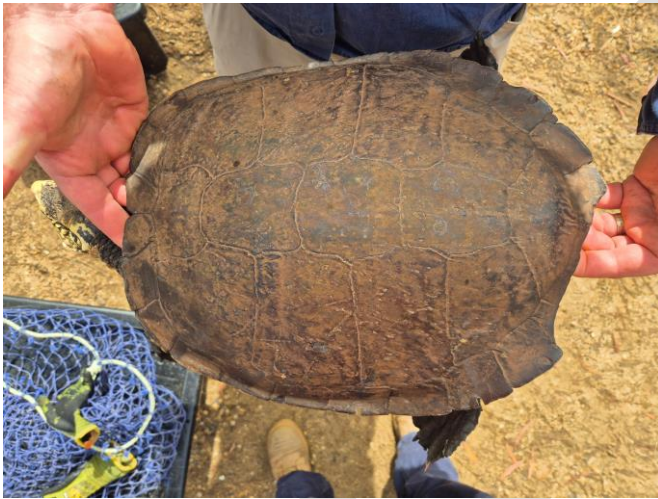
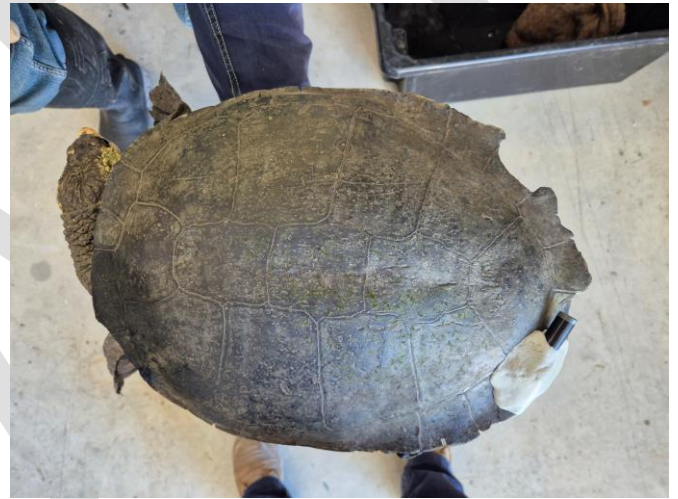
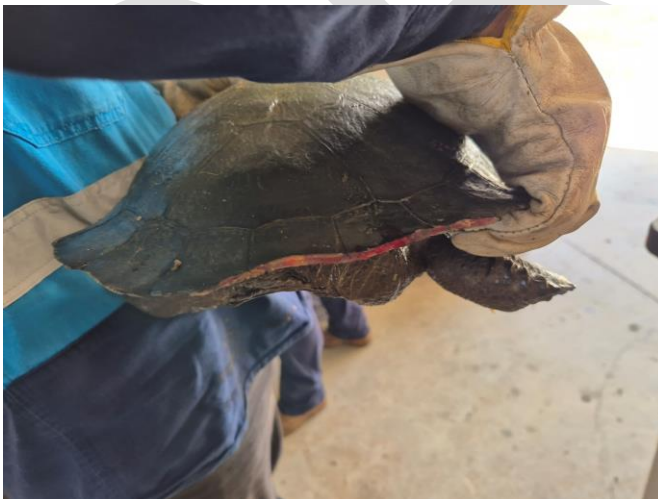
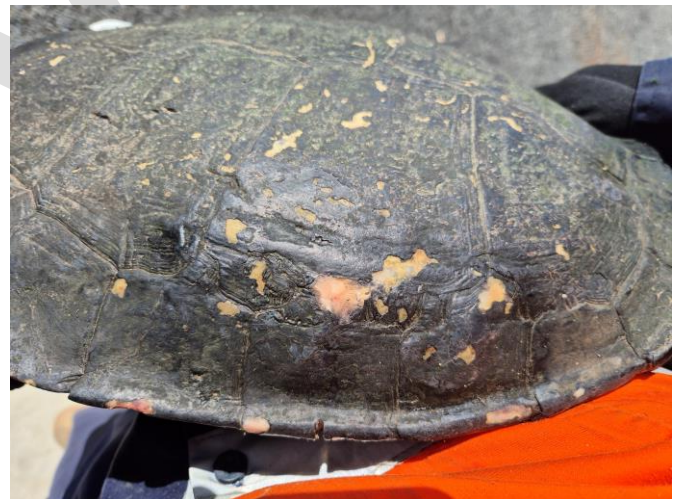
**Plate 3.6**

| Plate 3.6 | Examples of visible damage of turtles captured during May 2025 survey event, including: Krefft's turtle carapace damage (top left), white-throated snapping turtle fresh plastron graze (top right), and healed (middle row) and fresh (bottom row) carapace damage for several white-throated snapping turtles | 63 |

Overall, there was an increase in the number of white-throated snapping turtles with minor and major injuries was detected in Year 1 2024-25 in comparison to pre-construction and construction phase monitoring. Rates of injuries in Fitzroy River turtles were lower in Year 1 2024-25 in comparison to previous monitoring, however, one deceased adult Fitzroy River turtle was found by Sunwater on the right bank immediately adjacent to the Rookwood Weir abutment. The turtle was found in the advanced stages of decay, and the turtle's carapace had sustained severe damage indicative of forceful contact with a hard structure.

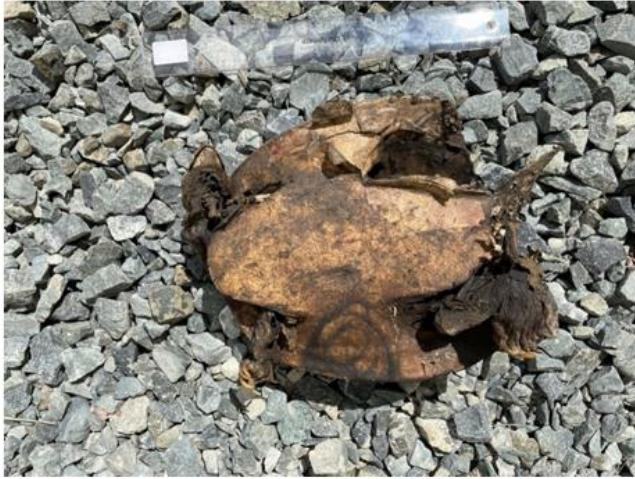
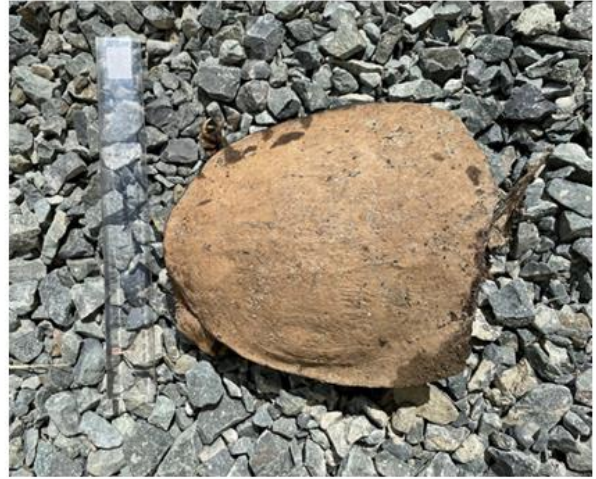
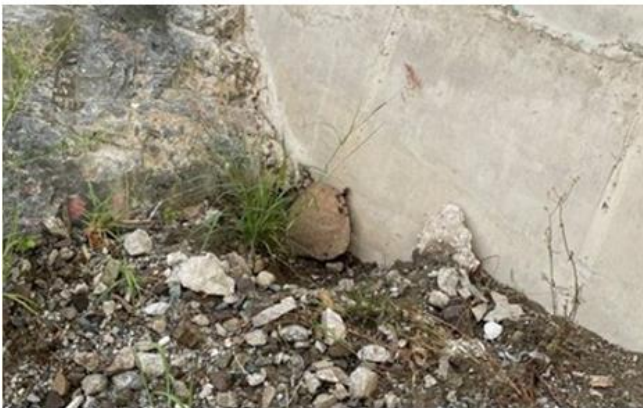
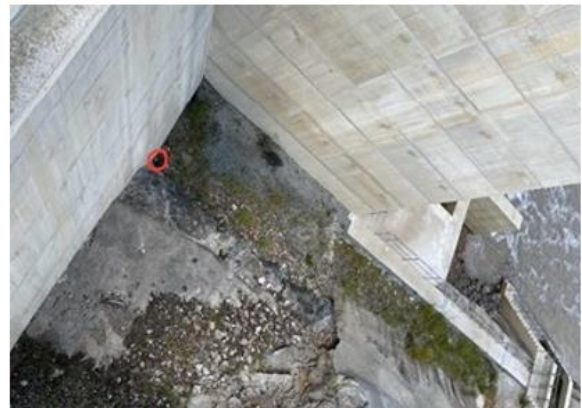
**Plate 3.12**      **Reported Fitzroy River turtle mortality**
