Rookwood Weir

Operations Phase - Annual Turtle Monitoring Report 2024-25

Tunuba and Sunwater 23 October 2025

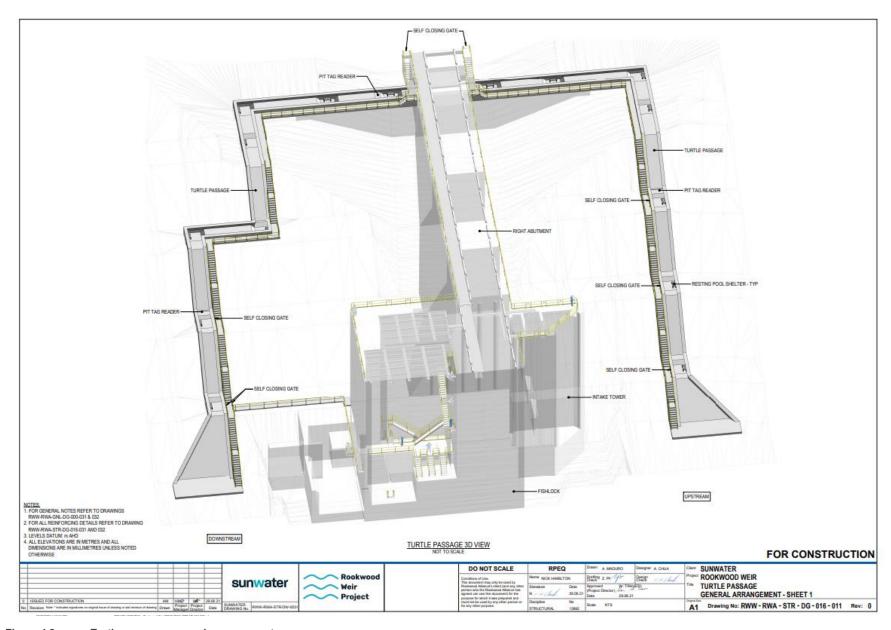
Figure 1.2 Turtle passage general arrangement

The turtle passage infrastructure at Rookwood Weir consists of a 172 m long by 2 m wide sloped turtle ramp with resting pools every 15 m (Figure 1.2). The ramp varies in slope up to a maximum of 45 degrees and is textured with exposed aggregate (5 mm greencut) to create a roughened surface for the turtles to grip. Stainless steel resting pool shelters provide shade and protection within each resting pool. A small attraction flow is provided down the ramp and permanent water is contained within the resting pools. The water is distributed through pipework with hand valves used to evenly distribute the discharge through each resting pool.

The turtle passage operates from 0.5 m below minimum headwater and tailwater levels, up to a 1 in 5-year spilling event. The entry and exit points of the turtle passage are located at the river margins where turtles can access them during low velocity conditions. A widened (6 m) funnel entrance/exit is provided both upstream and downstream to increase the area over which turtles can access the turtle passage at minimum headwater and tailwater conditions. The downstream entrance is immediately adjacent to the low flow outlet and fishway.

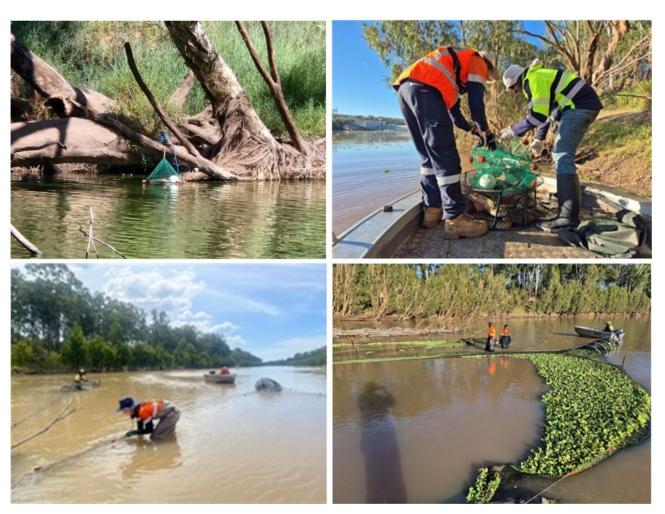
Plate 2.3 Broad-scale monitoring capture techniques: cathedral traps deployed (top left) and retrieved (top right), and fyke nets deployed in riffle habitats (bottom left), with flow contributing to accumulation of water lettuce in nets over time (bottom right).

For the broad-scale monitoring, turtle capture involved primarily cathedral traps and fyke netting (Plate 2.3). Cathedral traps were baited and set at survey locations for up to 24 hours (traps were checked twice during this period). Similarly, fyke nets were set for up to 24 hours (nets were checked twice during this period), however these were limited to shallow sections of the Fitzroy River, including riffle habitat downstream of Rookwood Weir and downstream of Hanrahan's Crossing. The high flow velocity present within the Fitzroy River during the survey in May 2025 made setting the nets difficult. The extensive water lettuce (*Pistia stratiotes*) downstream of Rookwood Weir also impacted trapping with fyke nets filled with plants overnight during this survey (Plate 2.3).

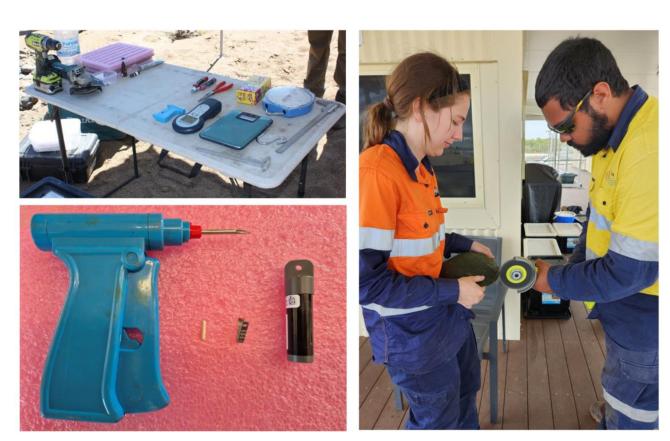
Plate 2.4 Turtle mark-recapture methods: field set up for measuring and tagging turtles (top left), turtle tagging equipment (bottom left) including from left to right – PIT tag applicator, PIT tag, monel foot tag, V13 acoustic tag, and coded carapace notching (right).

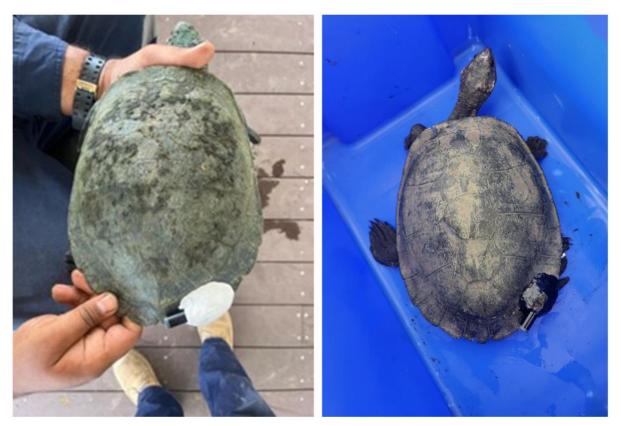
Plate 2.5 Acoustic tag before (left) and after camouflage painting (right)

The V13 acoustic transmitters were \sim 12 grams (g) in weight with dimensions of 45 mm length x 13 mm depth. The V9 transmitters were \sim 6 g in weight with dimensions of 41 mm length x 13 mm depth. Total weight of the tags was <1 % of an individual's body weight. The expected battery life of the V13 and V9 transmitters is approximately 1130 and 582 days, respectively, at which point they cease to function.

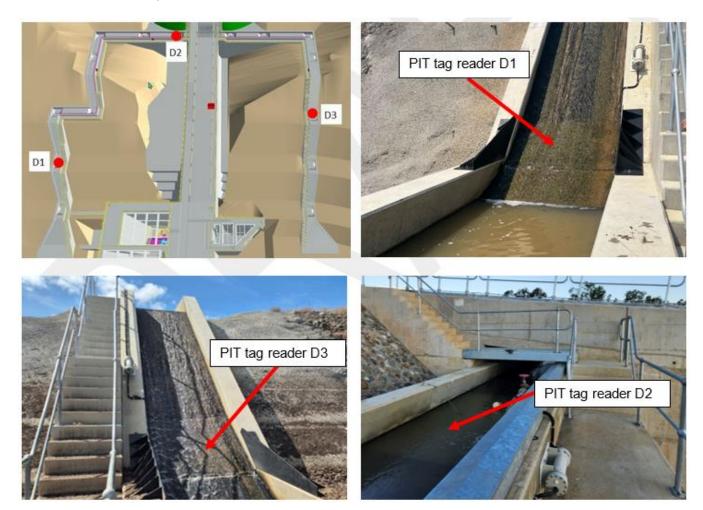
Plate 2.7 Location of three installed PIT tag readers along turtle passage (top left): D1 (top right), D2 (bottom left) and D3 (bottom right)

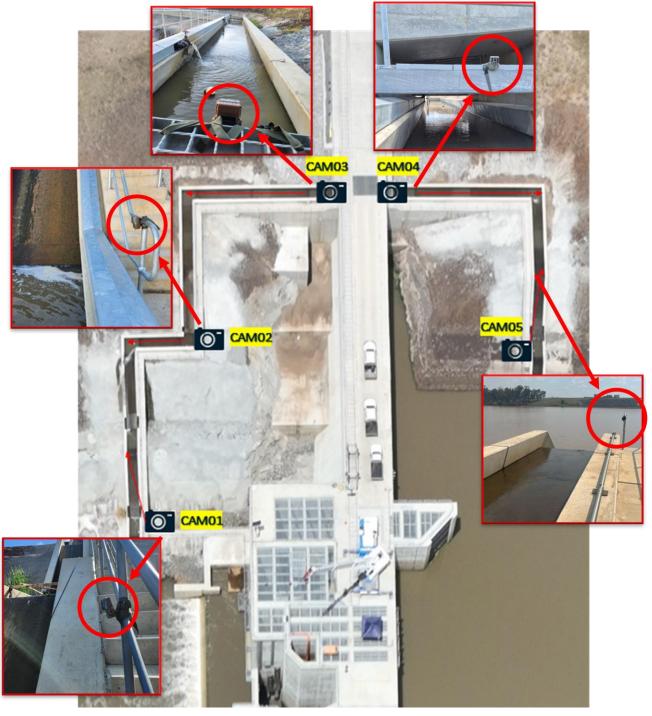
Figure 2.5 Turtle passage – remote camera locations

On 14 October 2024, five remote cameras (Browning Dark Ops Pro DCL Nano) were installed on the turtle passage infrastructure by Sunwater to view the entrance, middle and exit of the turtle passage (Figure 2.5). The cameras are motion triggered with photographs recorded on SD cards. This data is intended to assist in visually observing turtle movement and behaviour within the turtle passage infrastructure. Additionally, these cameras have been, and continue to be used in monitoring for falls, signs of predation and/or turtle aggression. Imagery captured by the cameras has been reviewed by Sunwater up to May 15, 2025, for Year 1 2024-25 of the operations phase monitoring. Images of turtles, and other fauna in or around the passageway were the uploaded to a central SharePoint for interpretation and integration into this report.

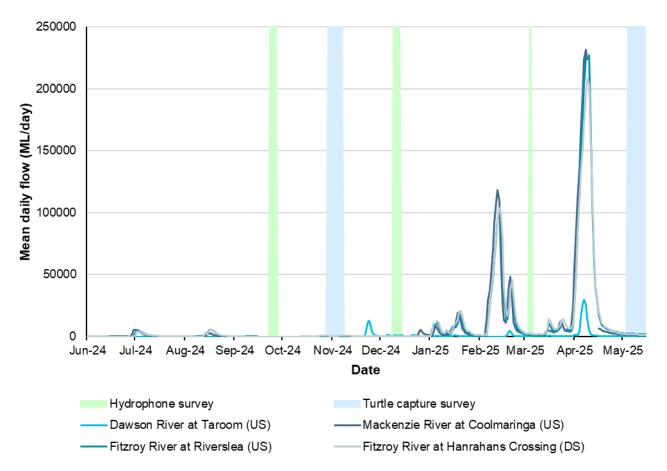
Figure 3.1 Mean daily flow (ML/day) at sites upstream (US) and downstream (DS) of Rookwood Weir from June 2024 – May 2025

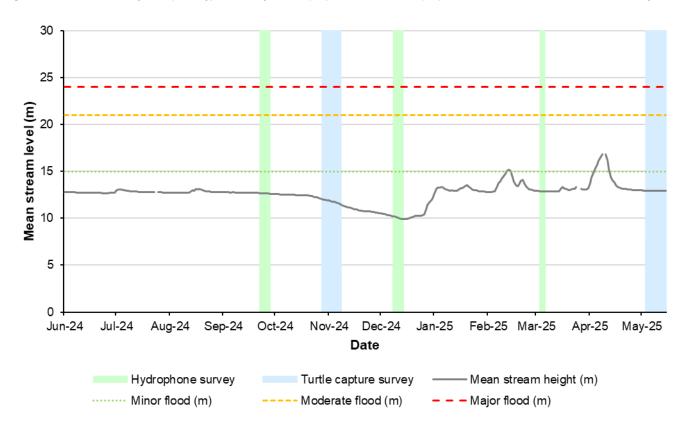
Figure 3.2 Mean stream level (m) for Fitzroy River at Riverslea (130003B) and define flood levels from June 2024 – May 2025

Based on recorded mean stream level at Riverslea which is an indicator of Rookwood Weir impoundment water level, water levels were relatively consistent throughout the year, including across hydrophone and turtle capture surveys (Figure 3.2). Water level at Riverslea was lowest in December 2024 but increased back to the weir FSL in January 2025. There were two minor flood events (>15 m at Riverslea) in mid-February 2025, and April 2025 (Figure 3.3), coinciding with higher flows during this period (Figure 3.1). No flooding occurred during hydrophone or turtle capture survey events.

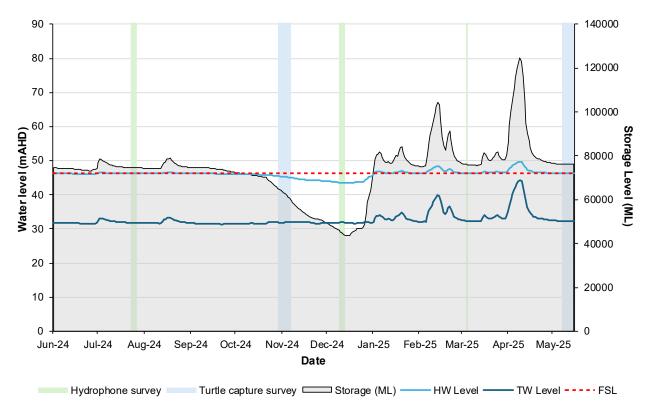
Figure 3.3 Headwater (HW) and tailwater (TW) levels (mean daily mAHD), full supply level (FSL 46.2 mAHD RL) and storage level (mean daily ML) at Rookwood Weir from June 2024 – May 2025

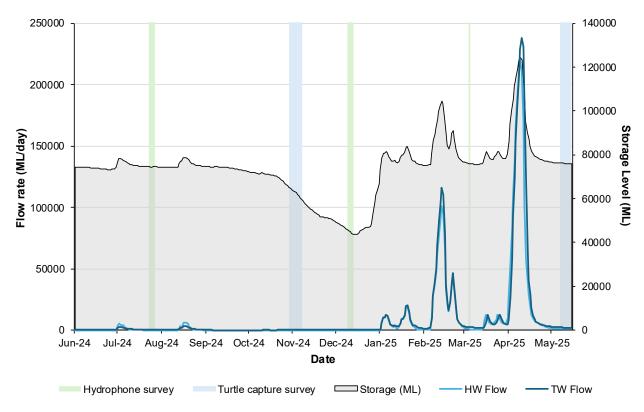
Figure 3.4 Headwater (HW) and tailwater (TW) daily flow rate (mean ML/day) and storage level (mean daily ML) at Rookwood Weir from June 2024 – May 2025

During the October/November 2024 turtle capture survey, whilst Rookwood Weir was not overtopping, water was being discharged from the low flow outlet. This release resulted in mean daily flow ranging from 393 ML/day to 744 ML/day downstream at Hanrahan Crossing (station 130010A) throughout the survey period (Figure 3.4).

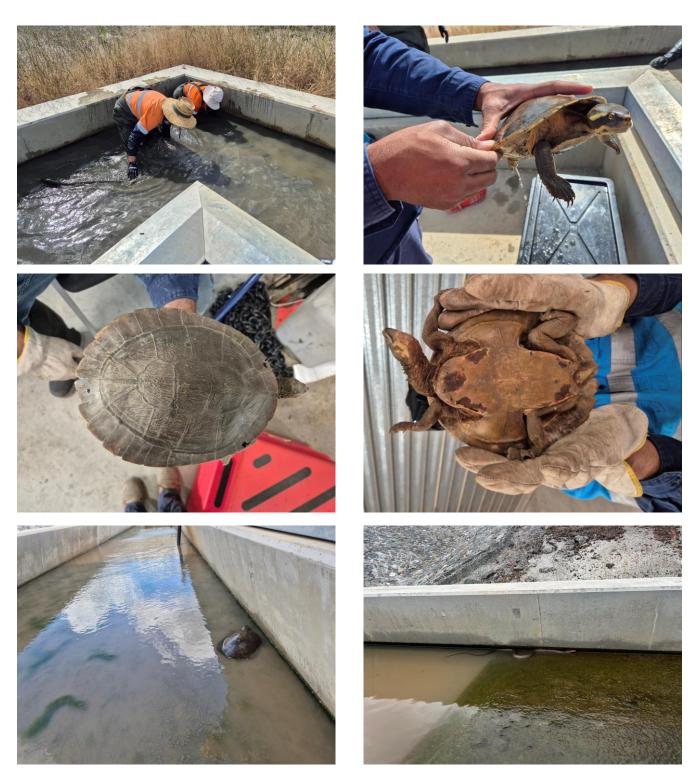
Plate 3.3 Muddling in resting pool DSRP3 (top left), Krefft's river turtle caught in turtle passage (top right), Fitzroy River turtle captured within turtle passage (middle left), damage to plastron of Fitzroy River turtle captured within turtle passage (middle right), saw-shelled turtle using turtle passage (bottom left), eastern brown snake observed in DSRP2 (bottom right).

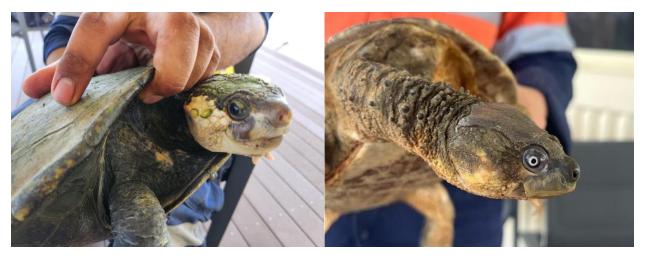
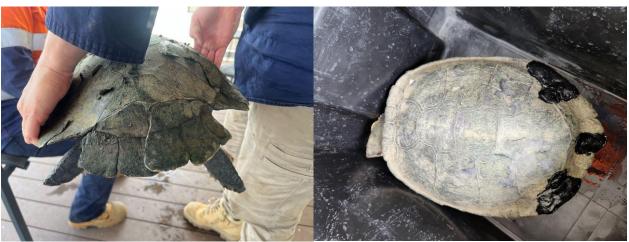
Plate 3.4 White-throated snapping turtle (top left); Fitzroy River turtle (top right) caught during October/November 2024 turtle capture surveys, and damaged carapace of a white-throated snapping turtle (bottom left); with carapace stabilised by epoxy (bottom right).

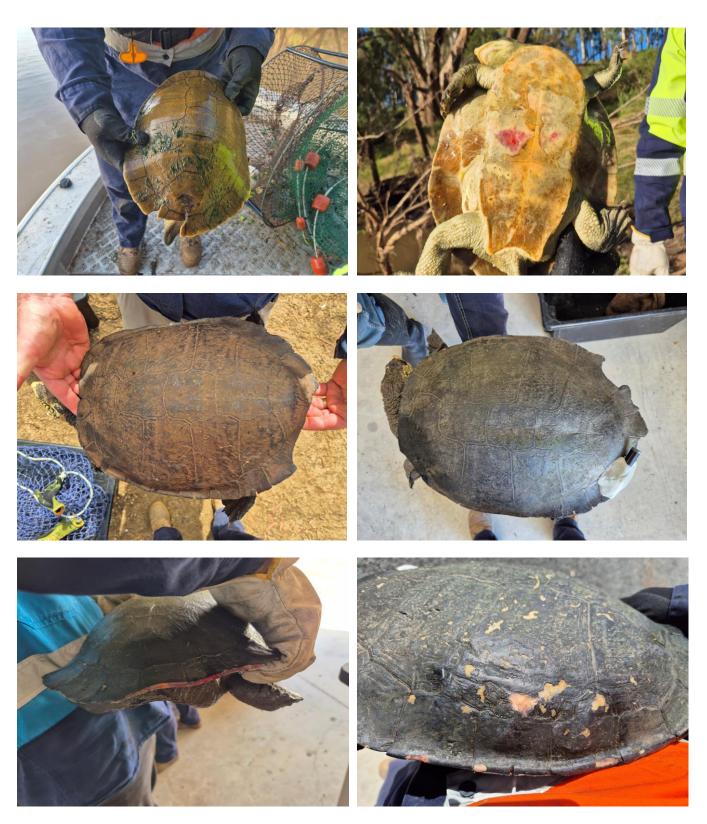
Overall, there was an increase in the number of white-throated snapping turtles with minor and major injuries was detected in Year 1 2024-25 in comparison to pre-construction and construction phase monitoring. Rates of injuries in Fitzroy River turtles were lower in Year 1 2024-25 in comparison to previous monitoring, however, one deceased adult Fitzroy River turtle was found by Sunwater on the right bank immediately adjacent to the Rookwood Weir abutment. The turtle was found in the advanced stages of decay, and the turtle's carapace had sustained severe damage indicative of forceful contact with a hard structure.

Plate 3.6 Examples of visible damage of turtles captured during May 2025 survey event, including: Krefft's turtle carapace damage (top left), white-throated snapping turtle fresh plastron graze (top right), and healed (middle row) and fresh (bottom row) carapace damage for several white-throated snapping turtles

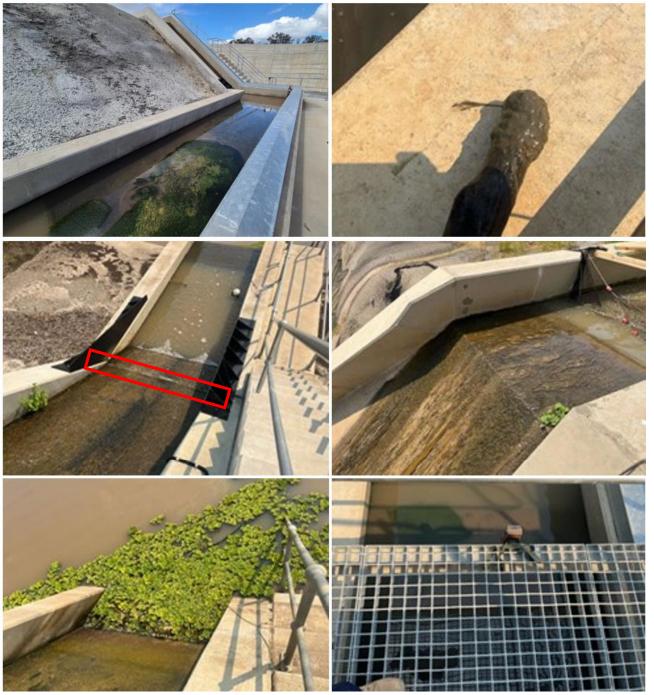
- Overall, habitat conditions within the turtle passage were suitable for turtles however, the small attraction flow
 at the funnel shaped entrance, high velocity flow on the ramp sections, algae growth, and sediment build up
 within resting pools were identified as having potential to impact turtle movement and/or habitat suitability.

Plate 3.10	Algae adjacent to DSRP5 (top left); silt/algae found at the bottom of resting pool USRP3 (top right); lip protruding from the join on the ramp which may pose a risk to turtles (middle left), water lettuce and algae on ramp near DSRP8 (middle right), and at approach channel upstream (bottom left), accumulation of gravel/debris along abutment tunnel (bottom right)	110
Dista 0.44	, , ,	
Plate 3.11	Reported turtle observations on left bank (left), turtle passage (right)	111
Plate 3.12	Reported Fitzroy River turtle mortality	112

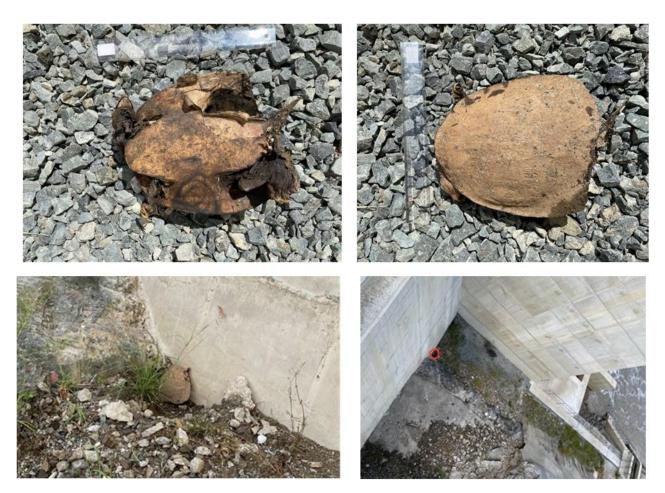
Plate 3.12 Reported Fitzroy River turtle mortality

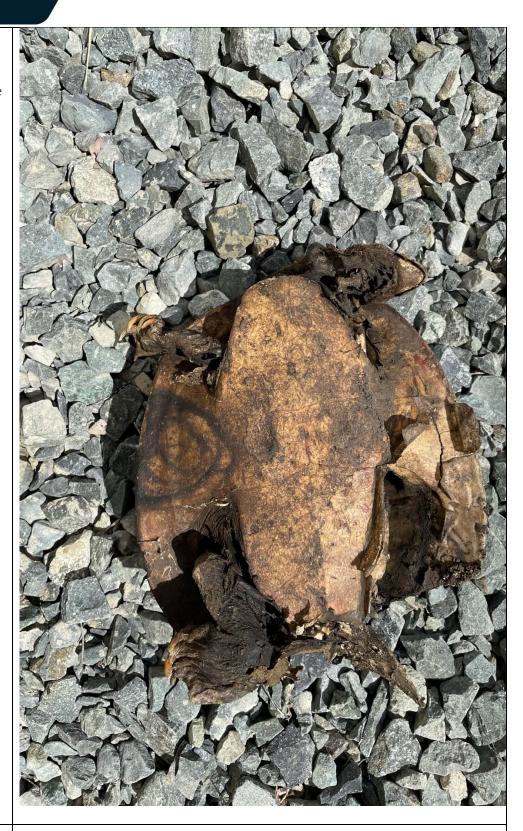
Fig 5 Turtle insitu from a closer perspecti ve
