EMERGENCY ACTION PLAN — TINAROO FALLS DAM (ID 370)

ISSUE: 10.1 — September 2023

Prepared by Sunwater Limited

Type: Mass concrete gravity dam

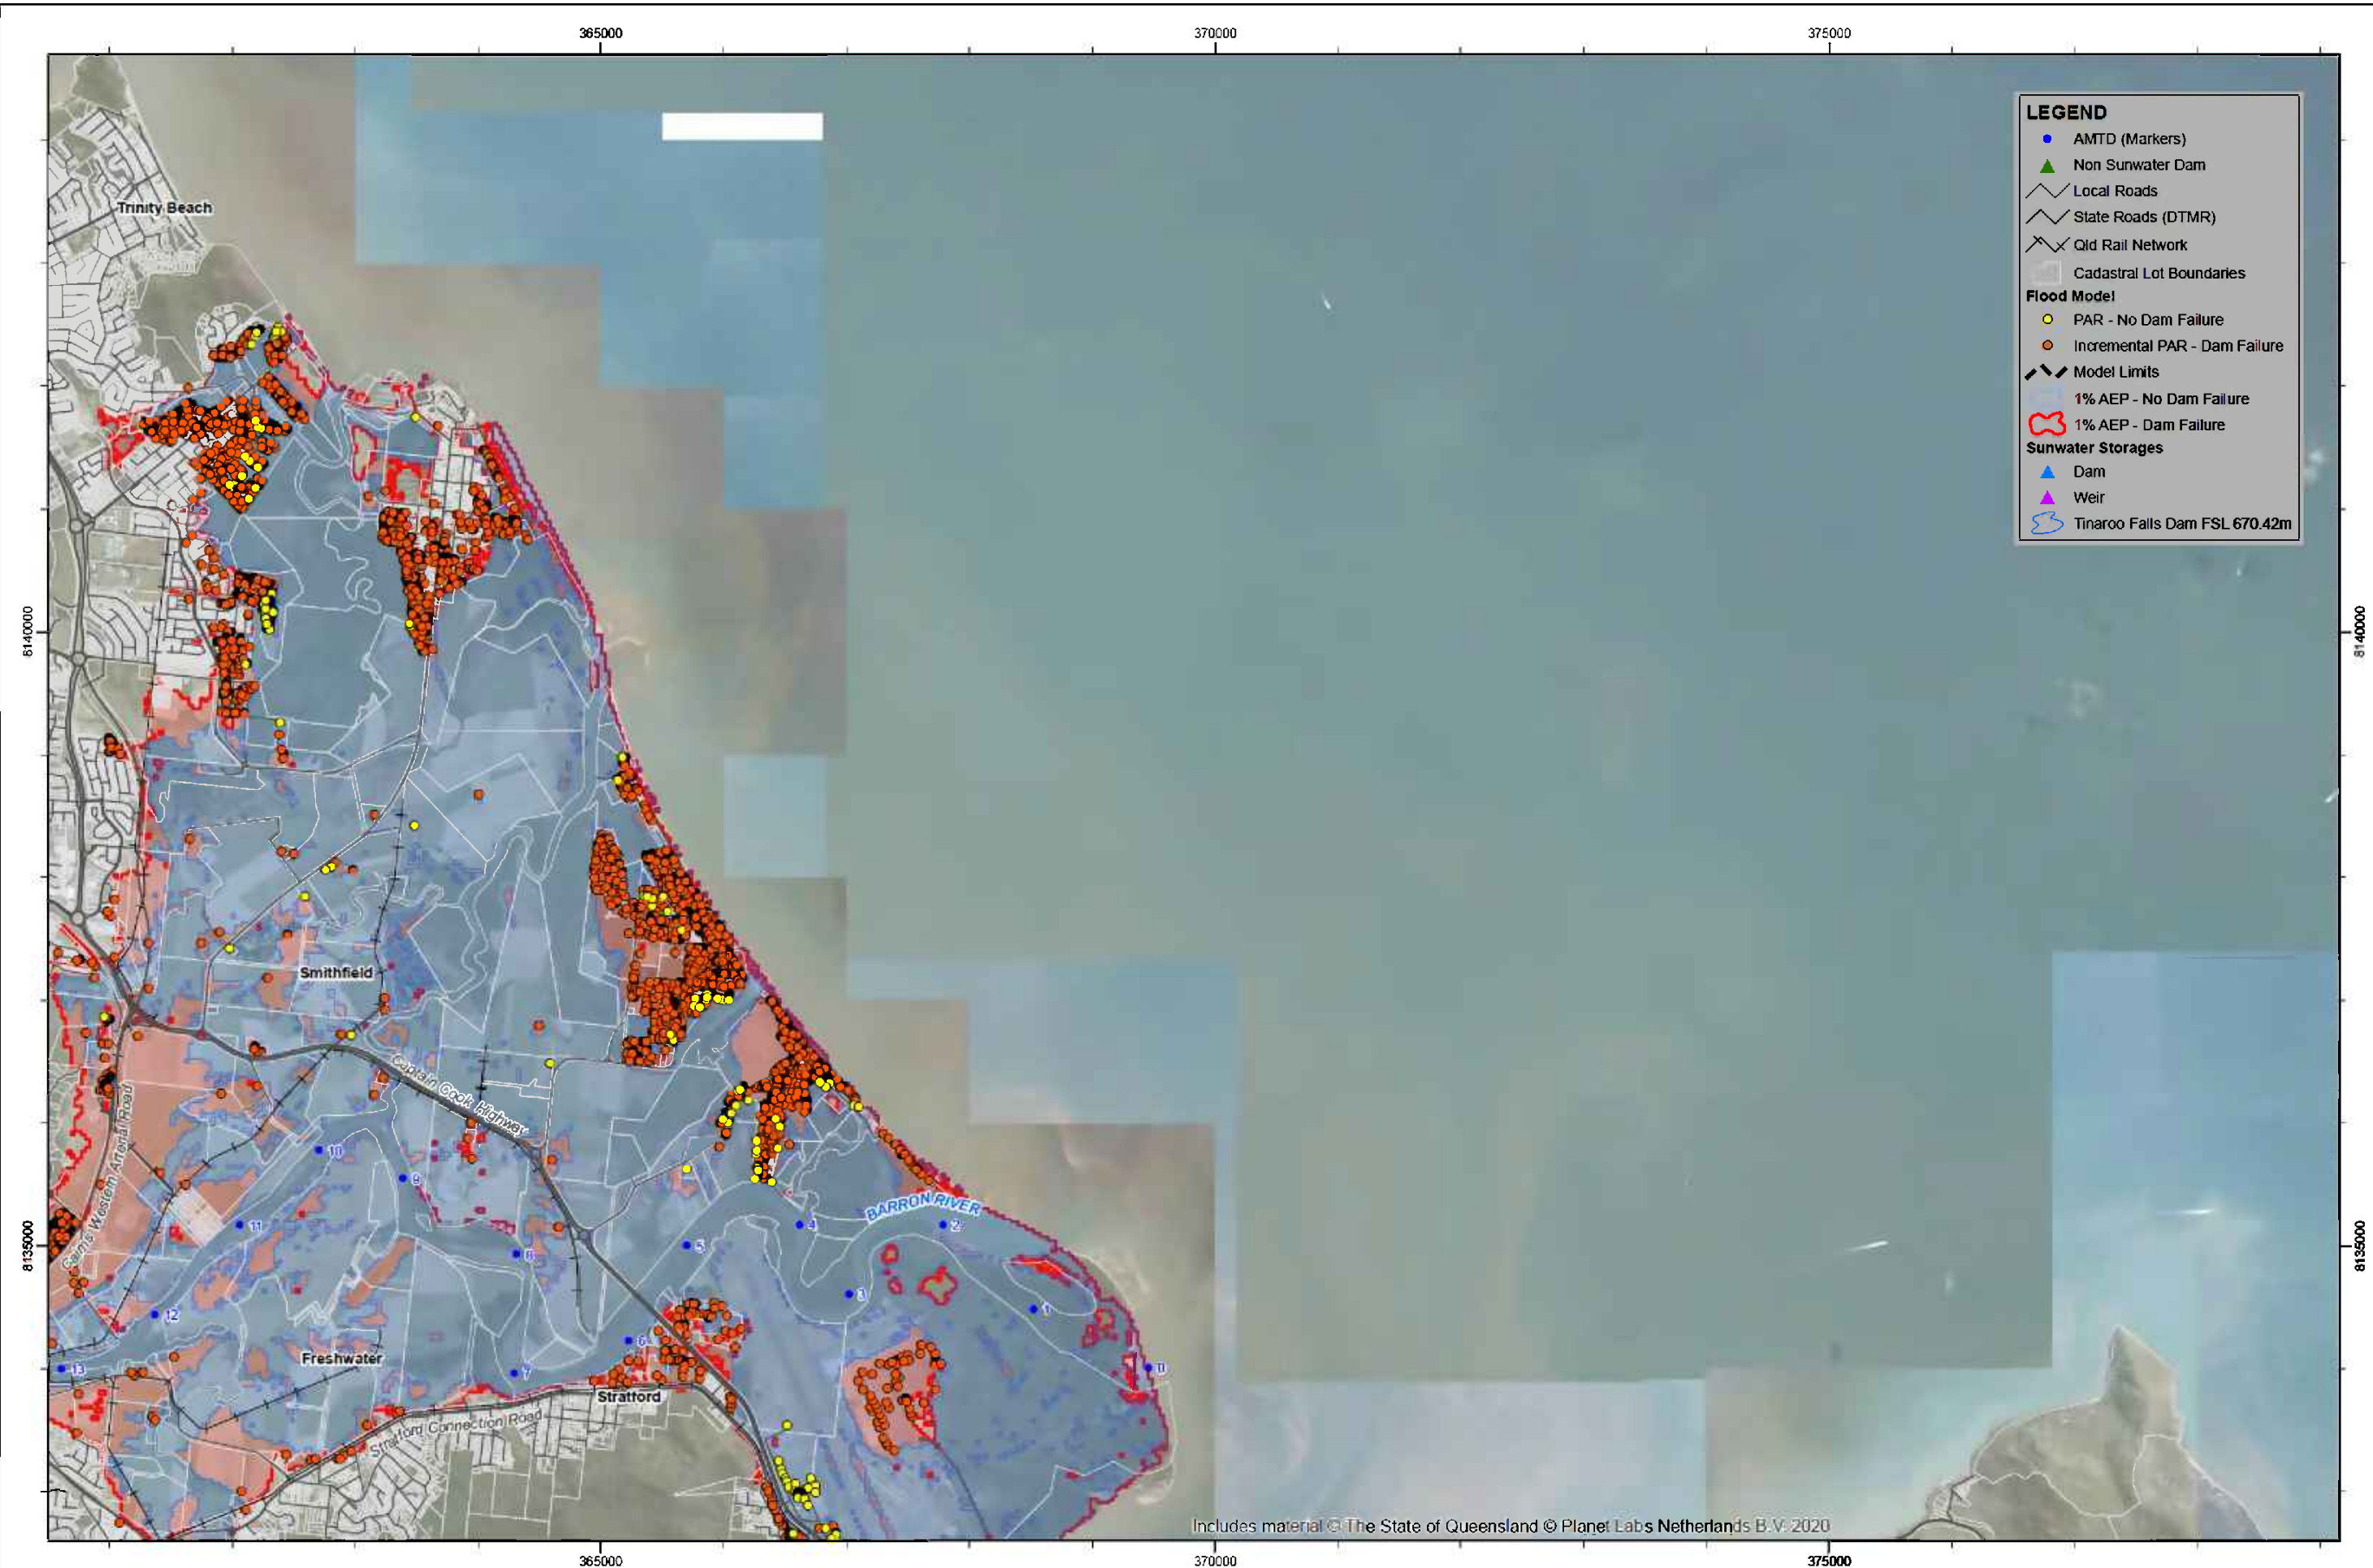
**TINAROO FALLS DAM
 DAM BREAK ANALYSIS 2022
 1% AEP FLOOD (1 IN 100 YEAR)
 PRIMARY SPILLWAY FAILURE
 INUNDATION PLAN**

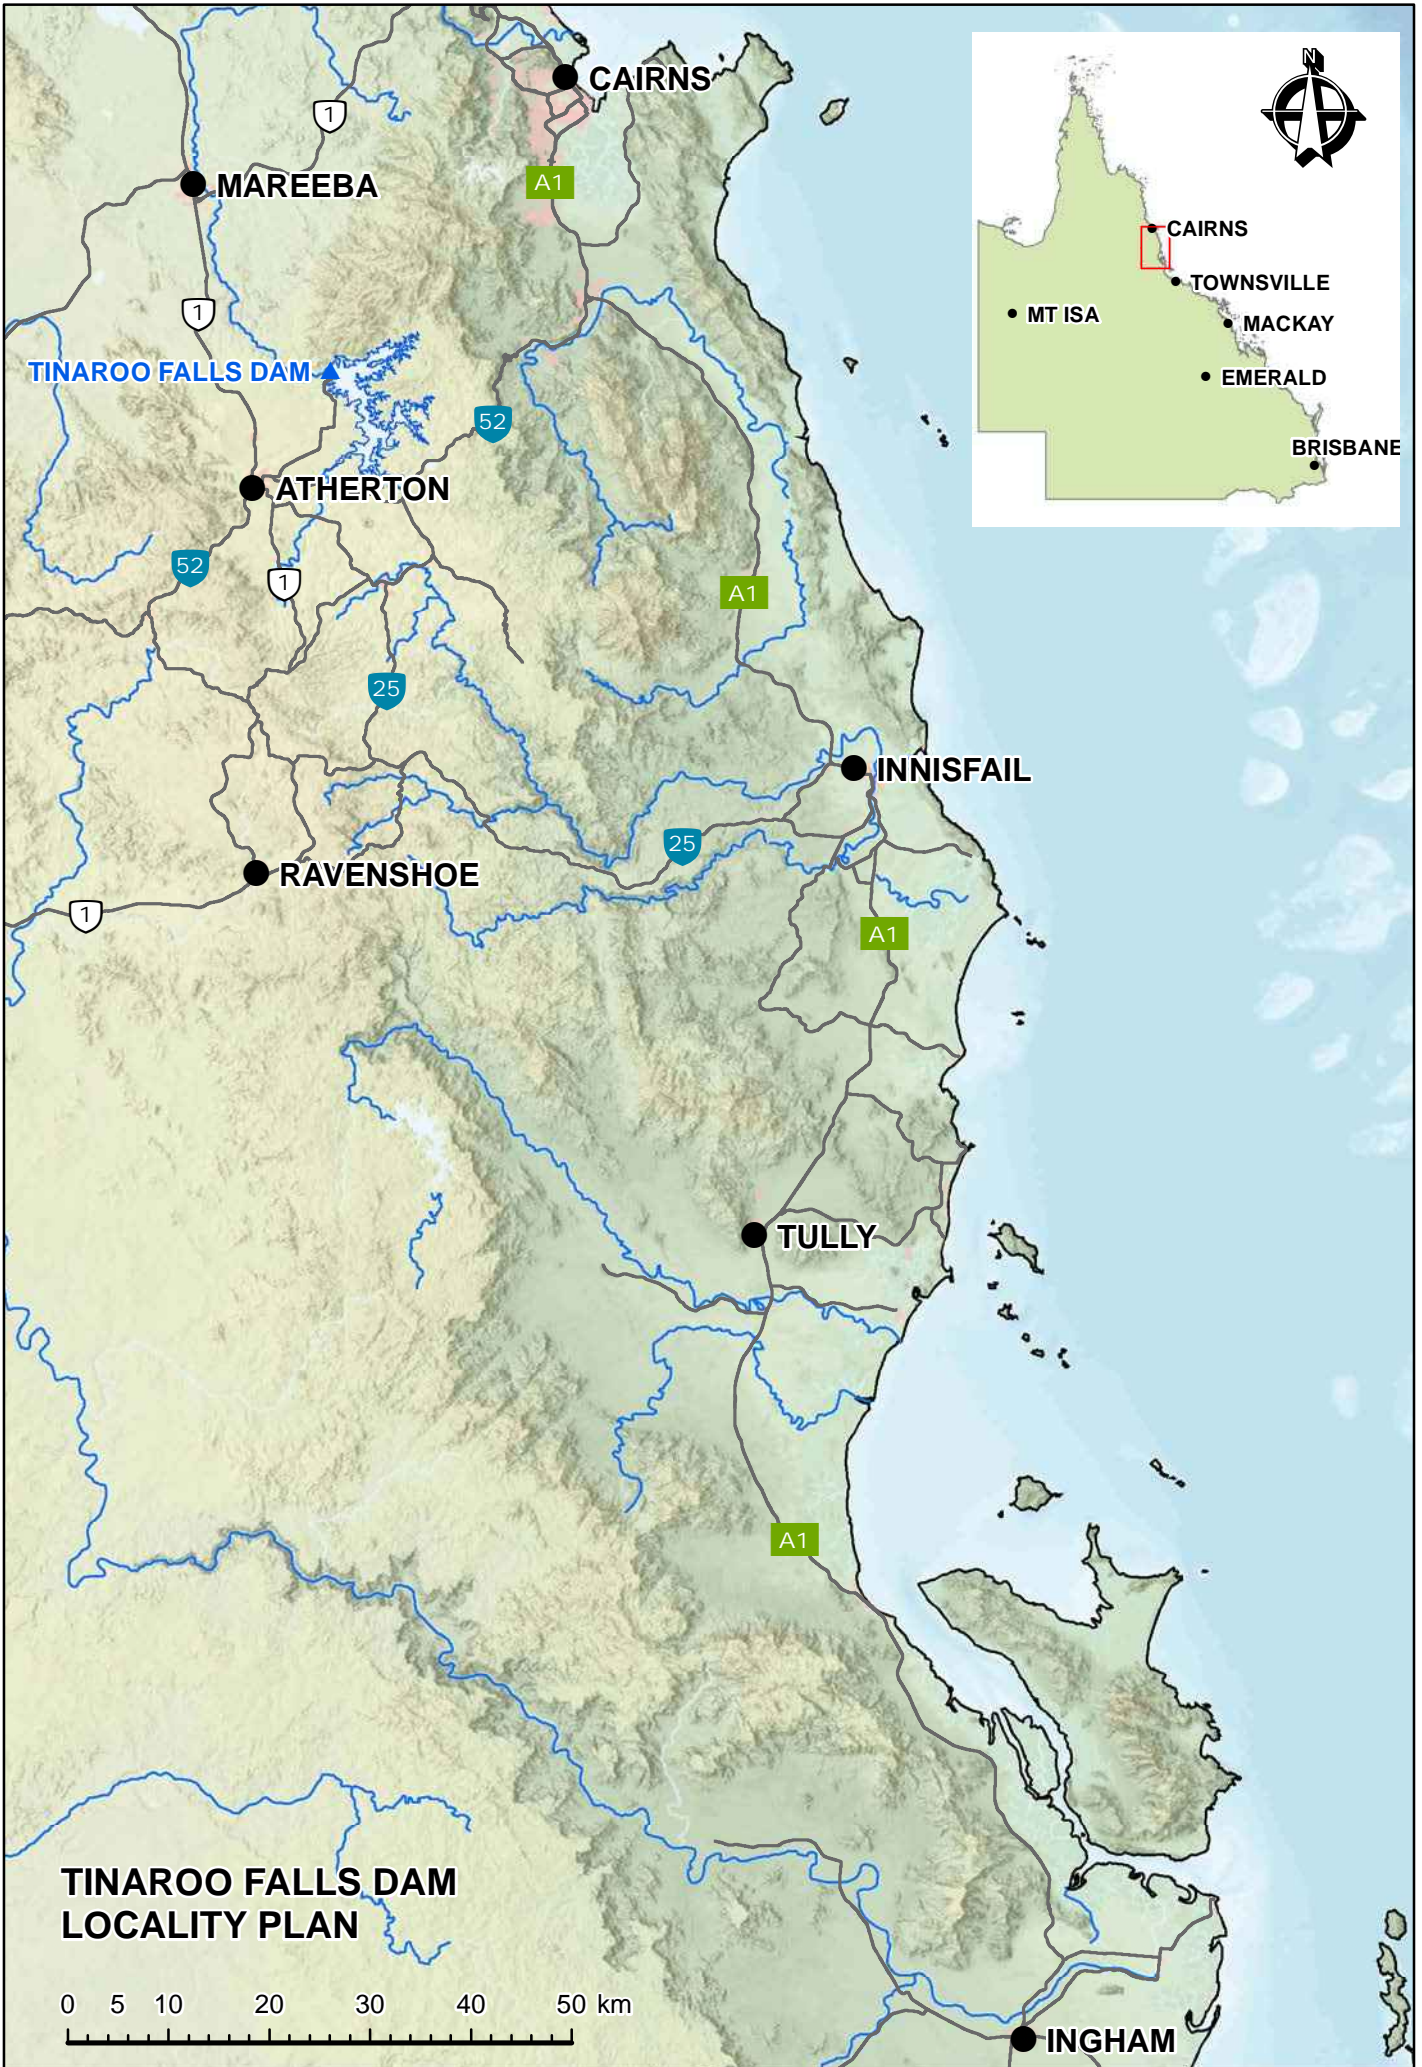
TINAROO FALLS DAM ACCESS ROUTES DURING ADVERSE WEATHER CONDITIONS

The next two (2) pages are maps of access routes during fair and adverse weather conditions.

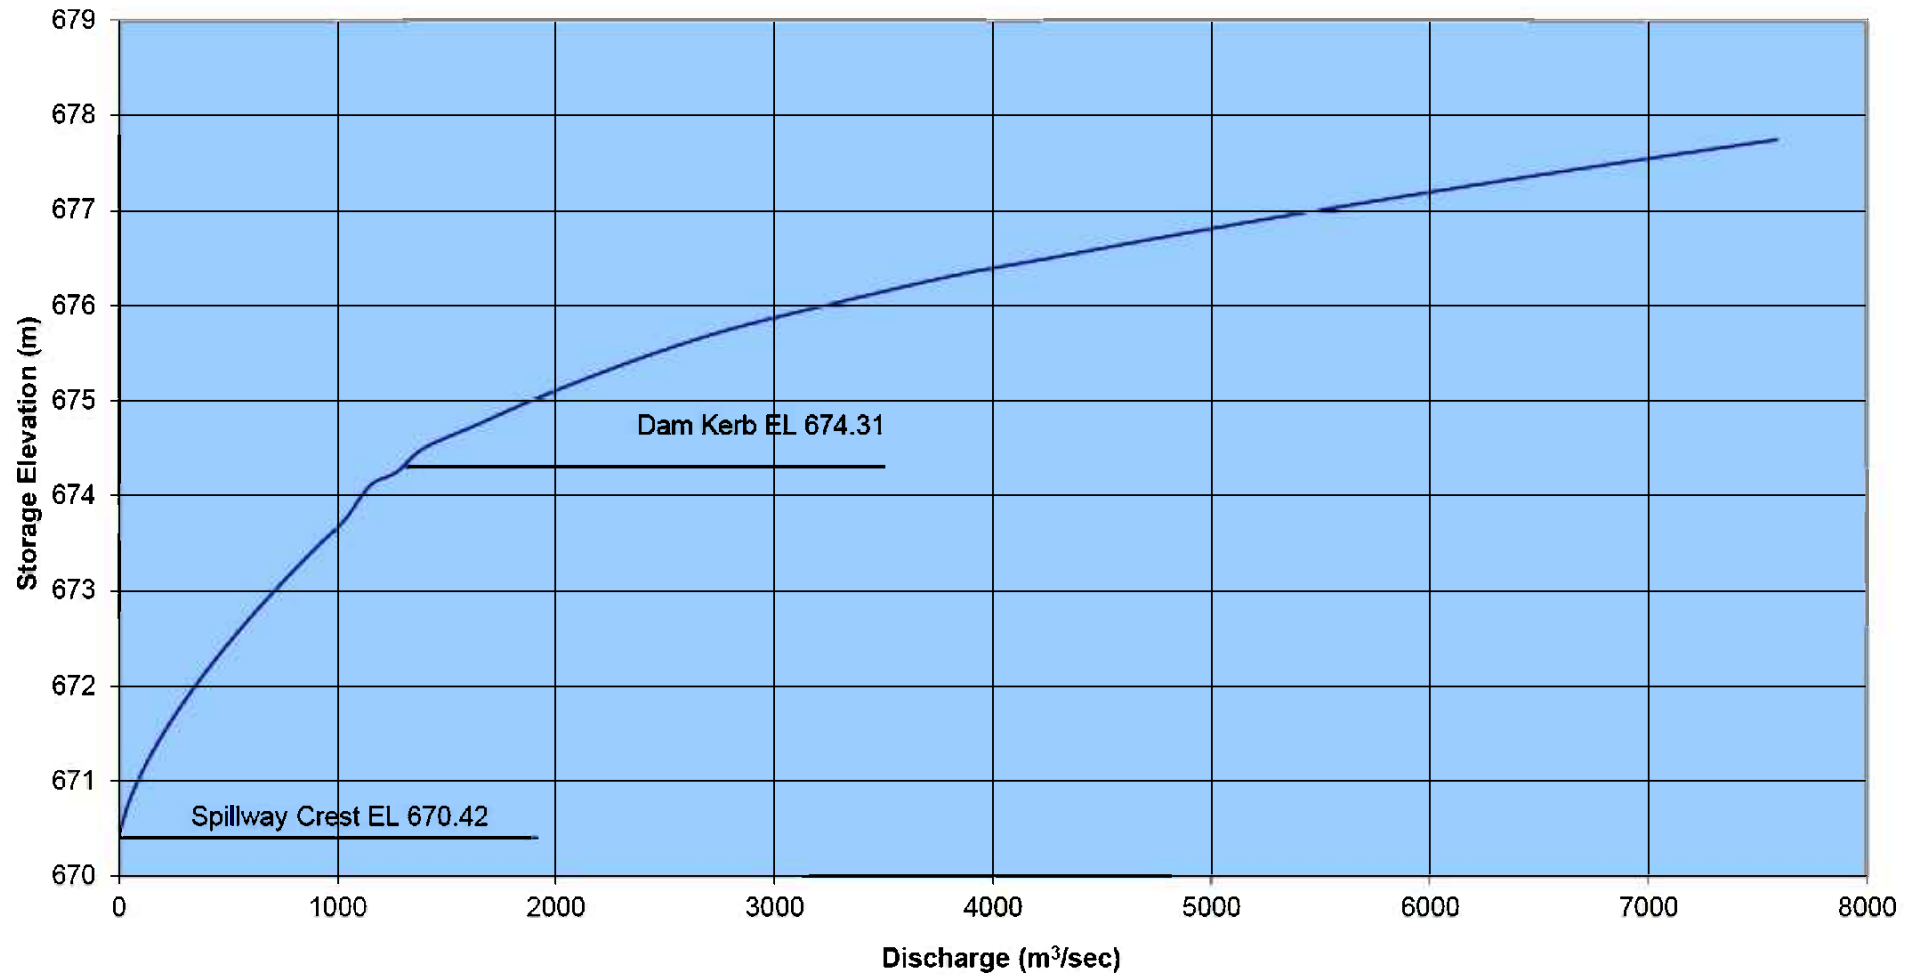
**Tinaroo Falls Dam Spillway Capacity Upgrade 2010
Spillway Rating Curve (Including flow over non-spillway monoliths)**

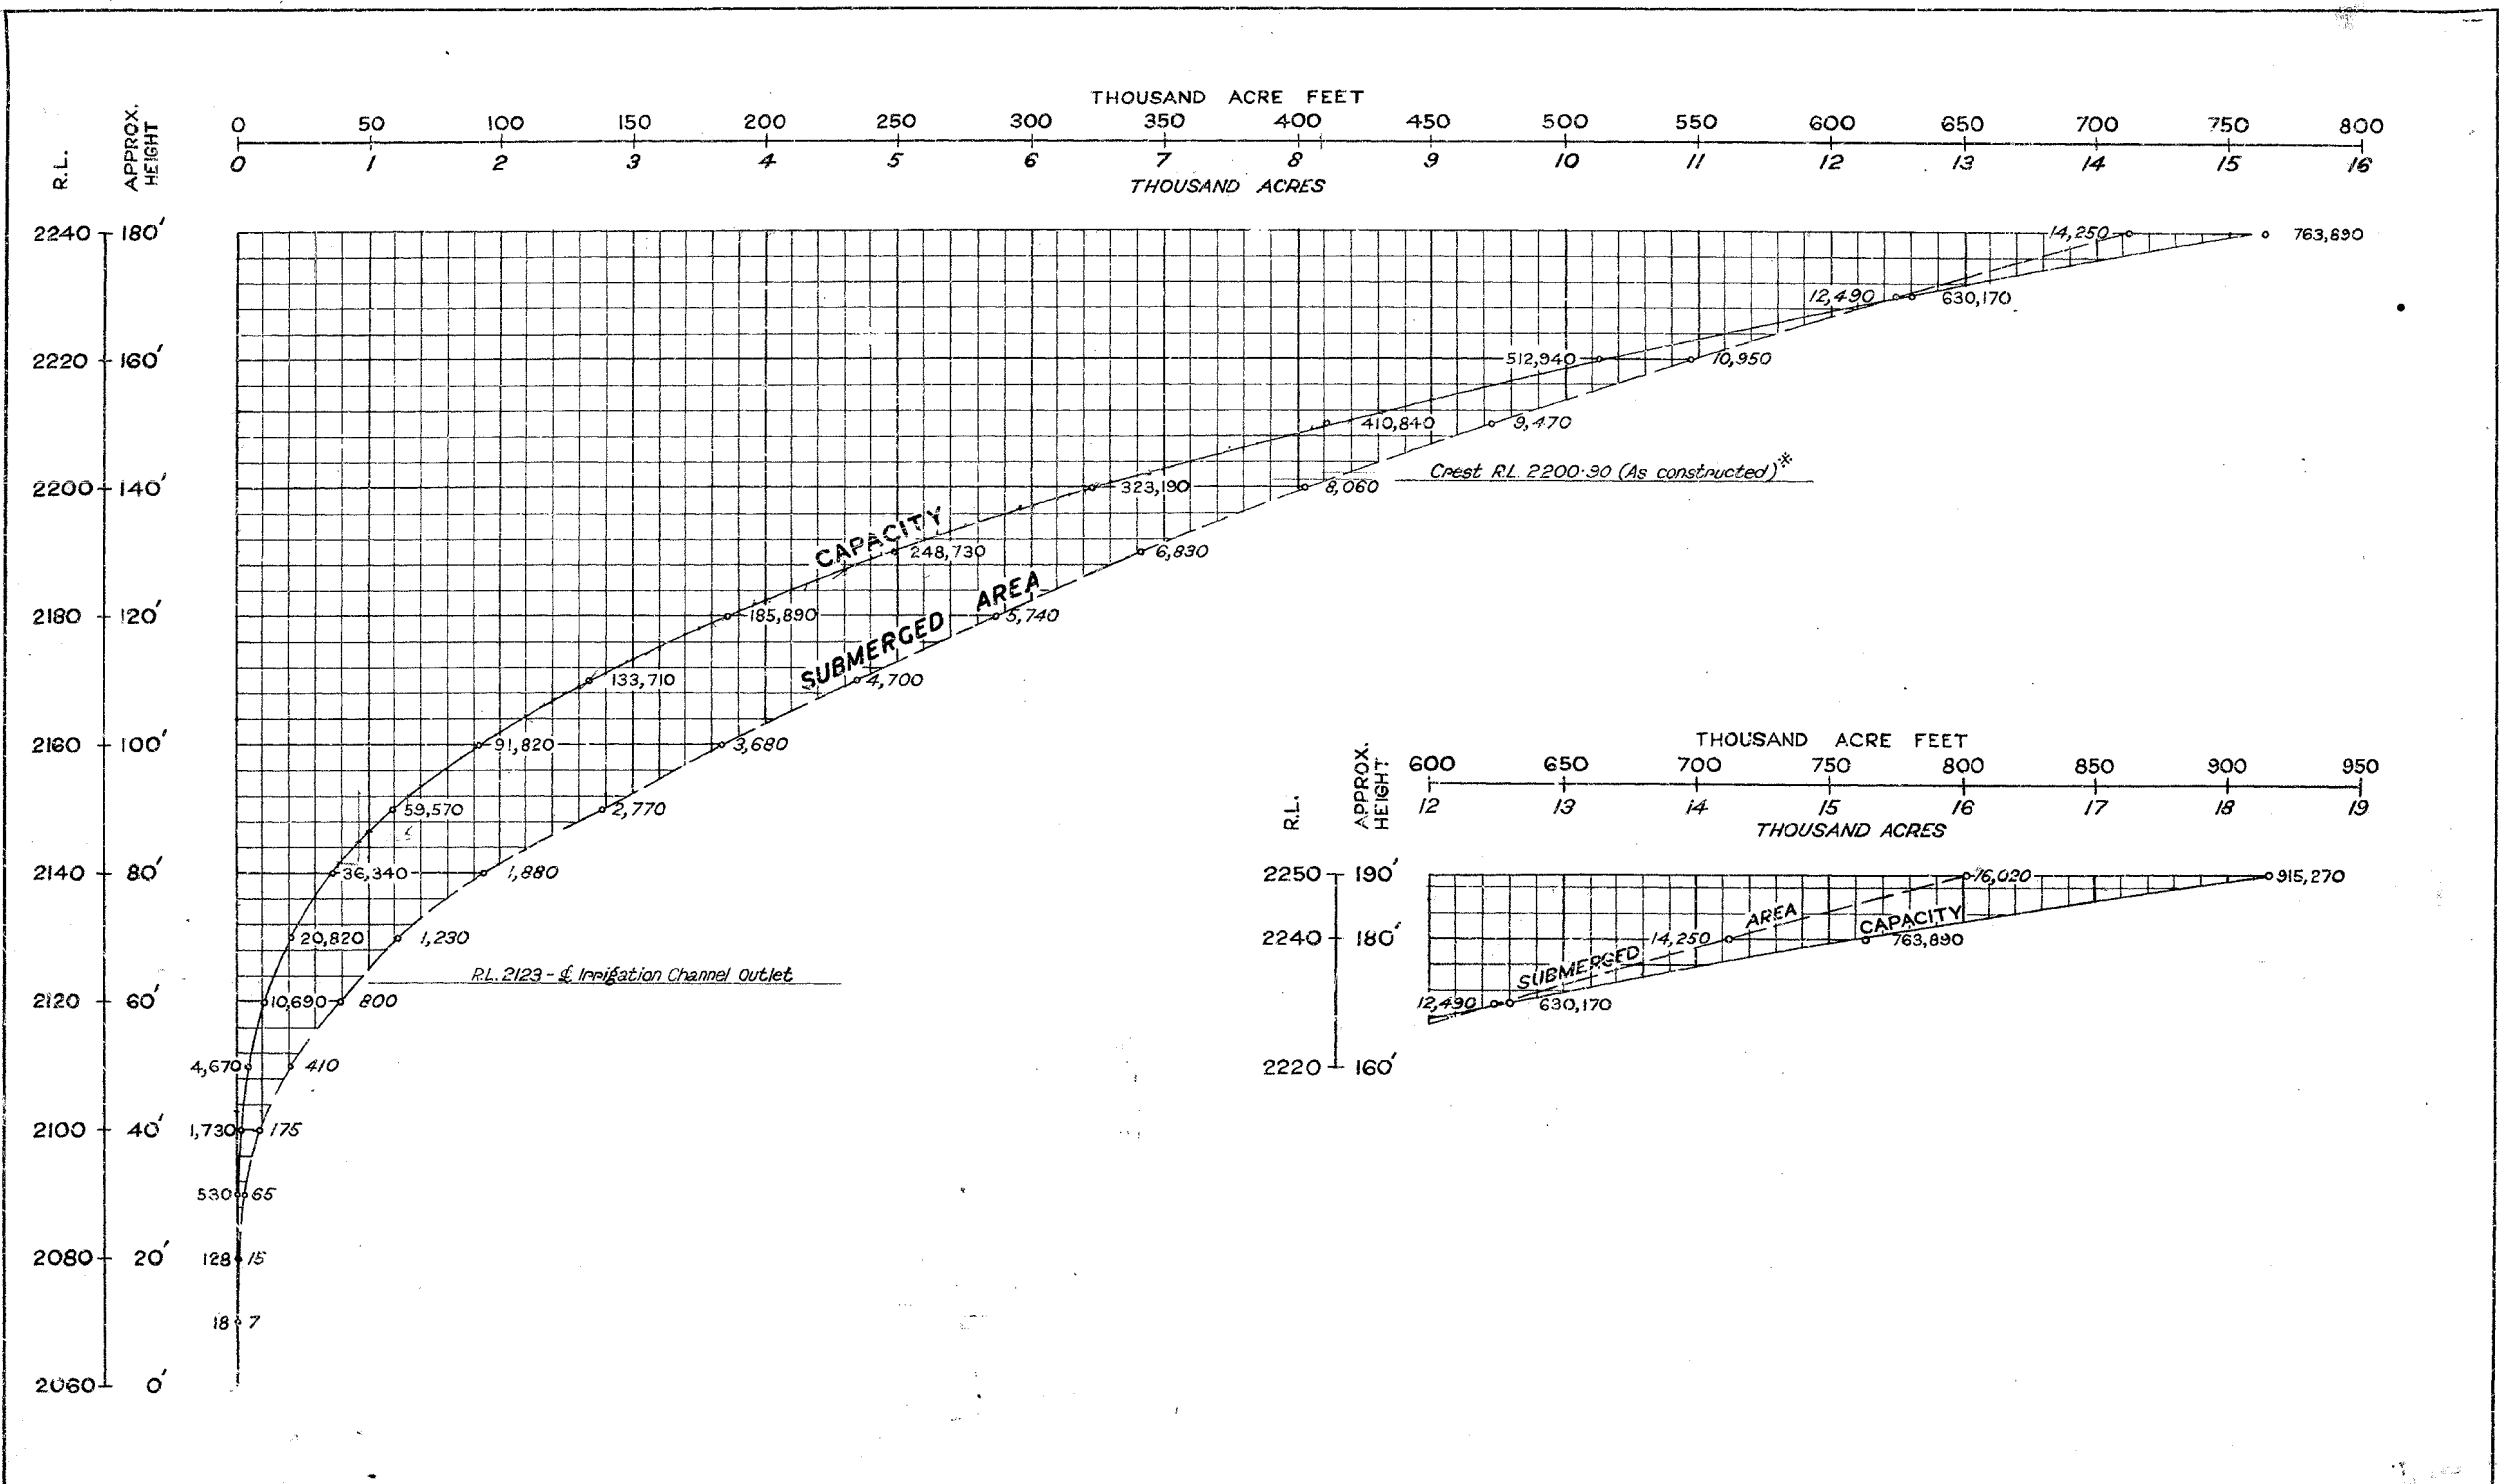
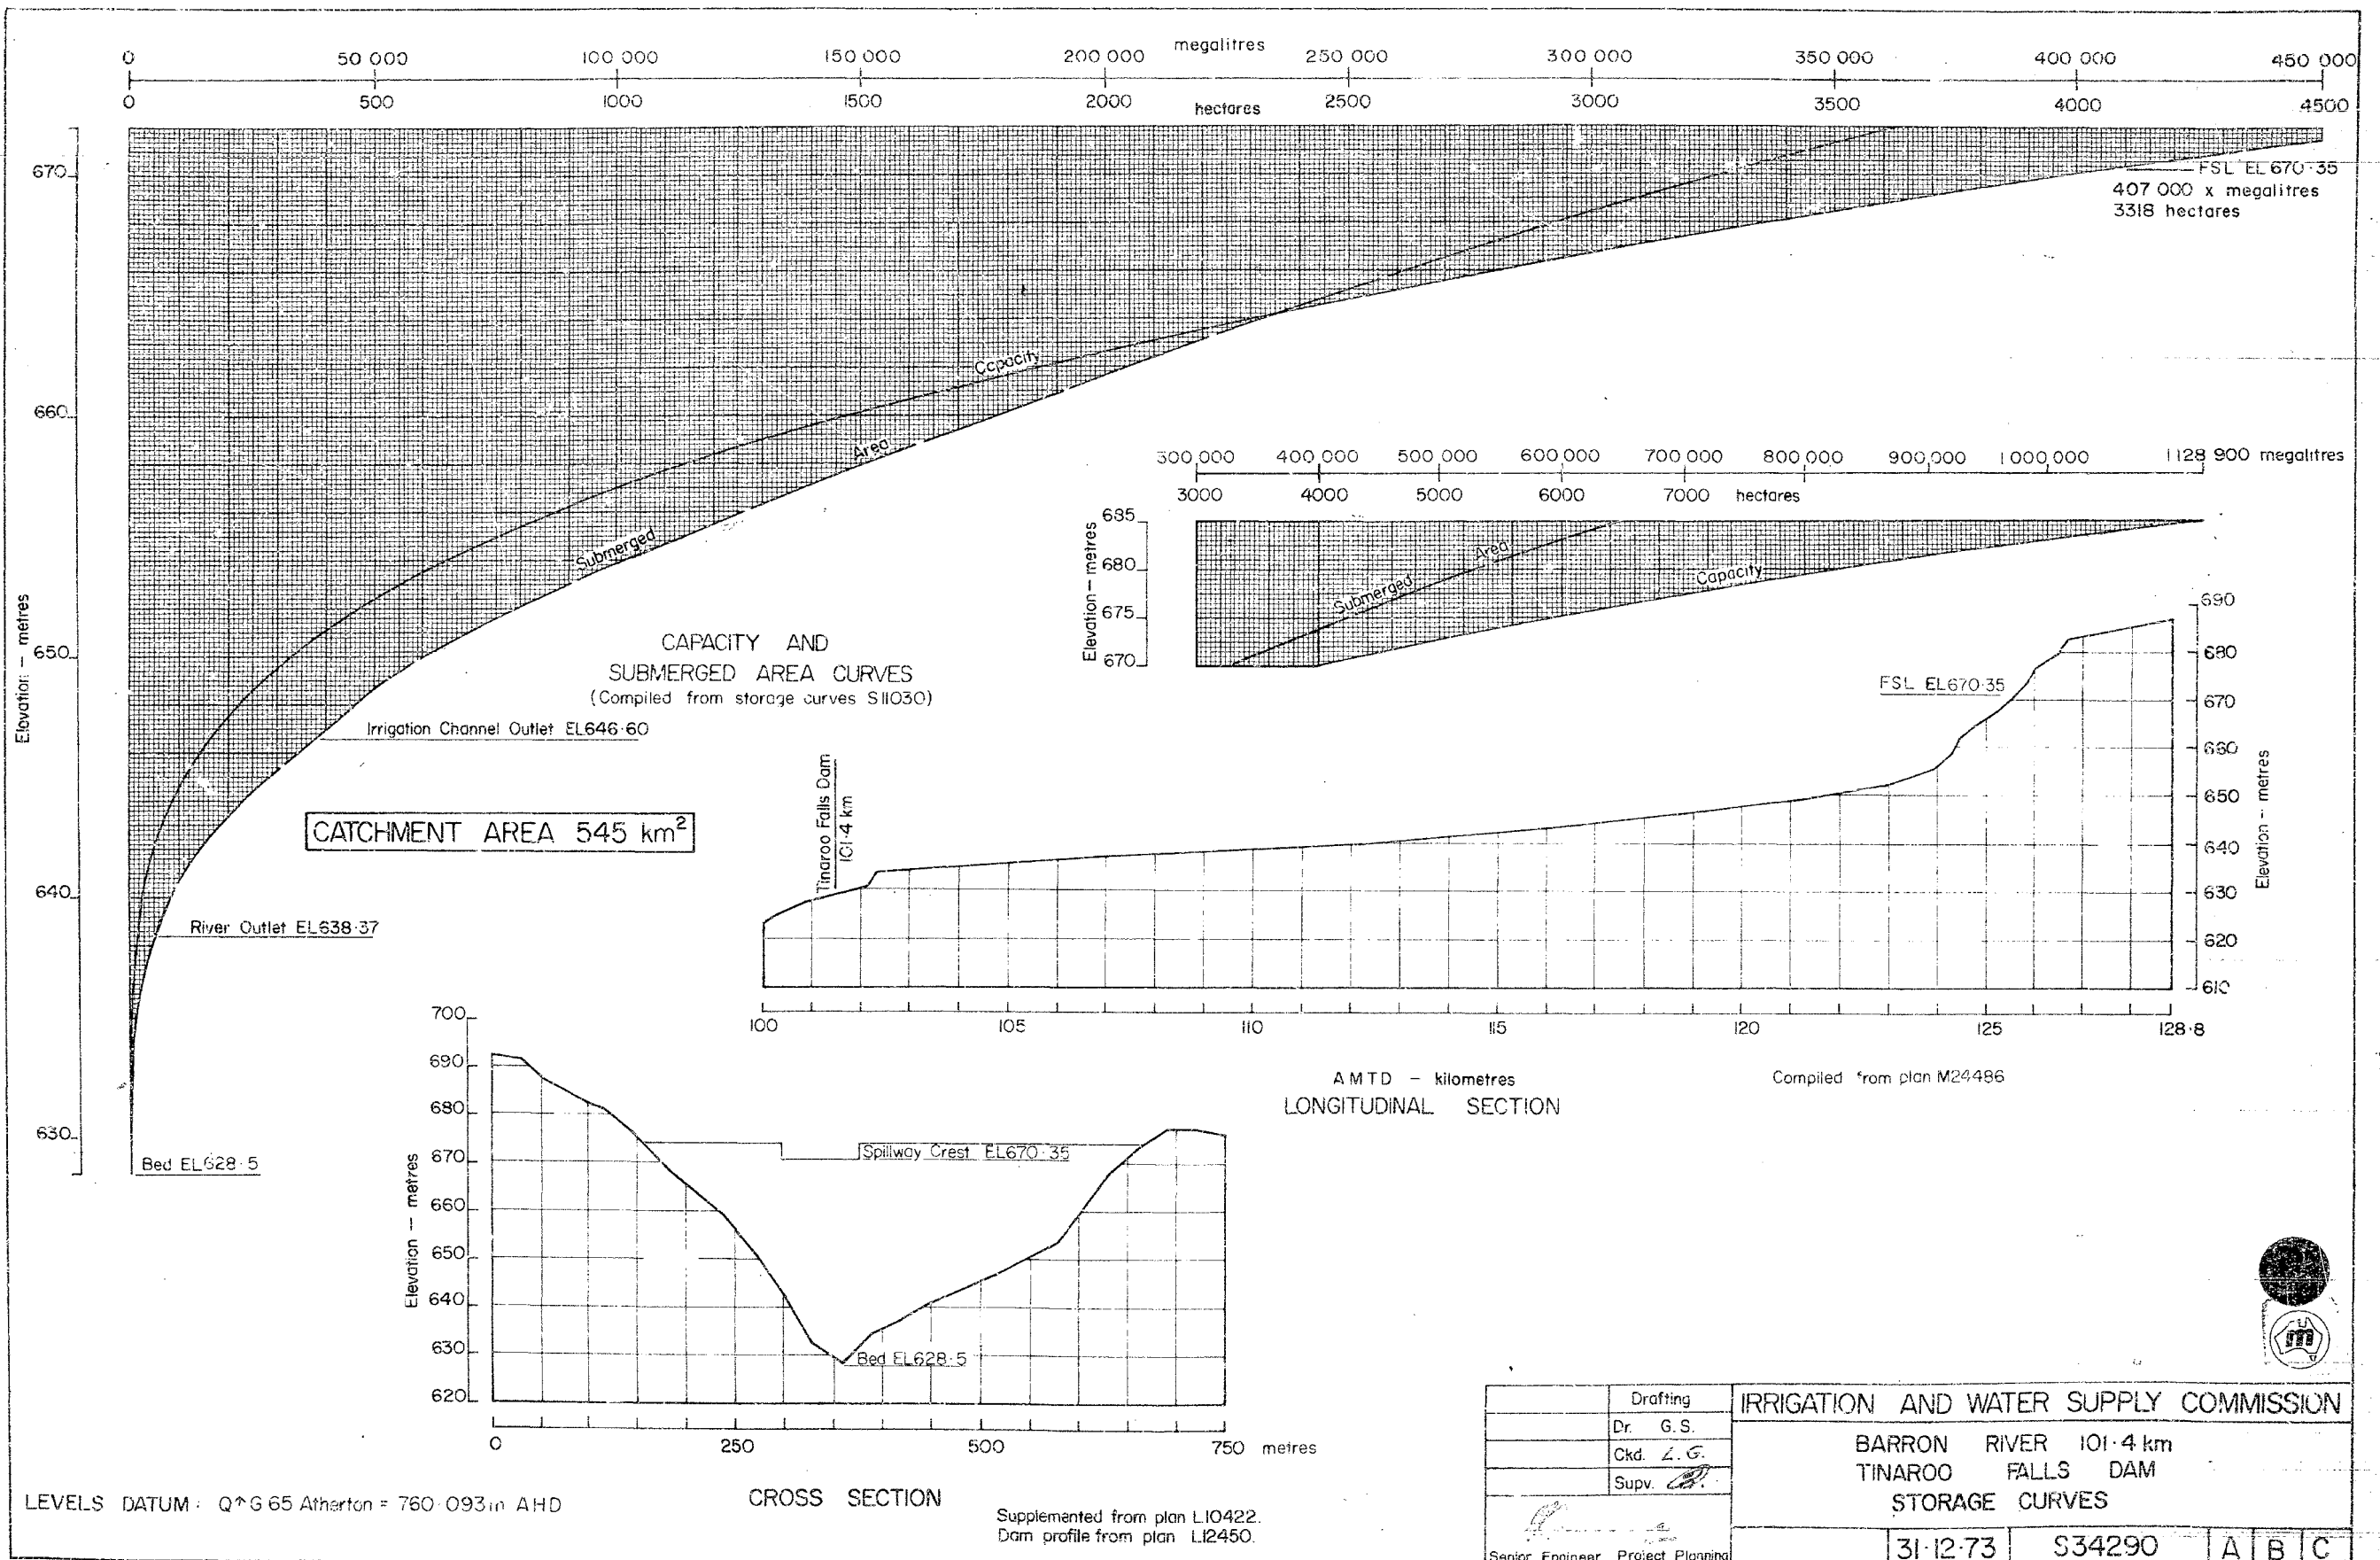
Compiled from Aerial Survey (Astrax) Contour Plans R.N. 10763-70.
 Levels Datum:- Tinaroo Falls (Deduct 0.56' to equate to State Datum (Athenon).)

* Crest Level at lowest point - Monolith 16 R.L. 2200.902 (See as constructed levels on File 6808-J/1 - 3.2.59).
