EMERGENCY ACTION PLAN — COOLMUNDA DAM (ID 254)

ISSUE: 8.0

Prepared by Sunwater Limited

Type: Earth and rock-fill embankment

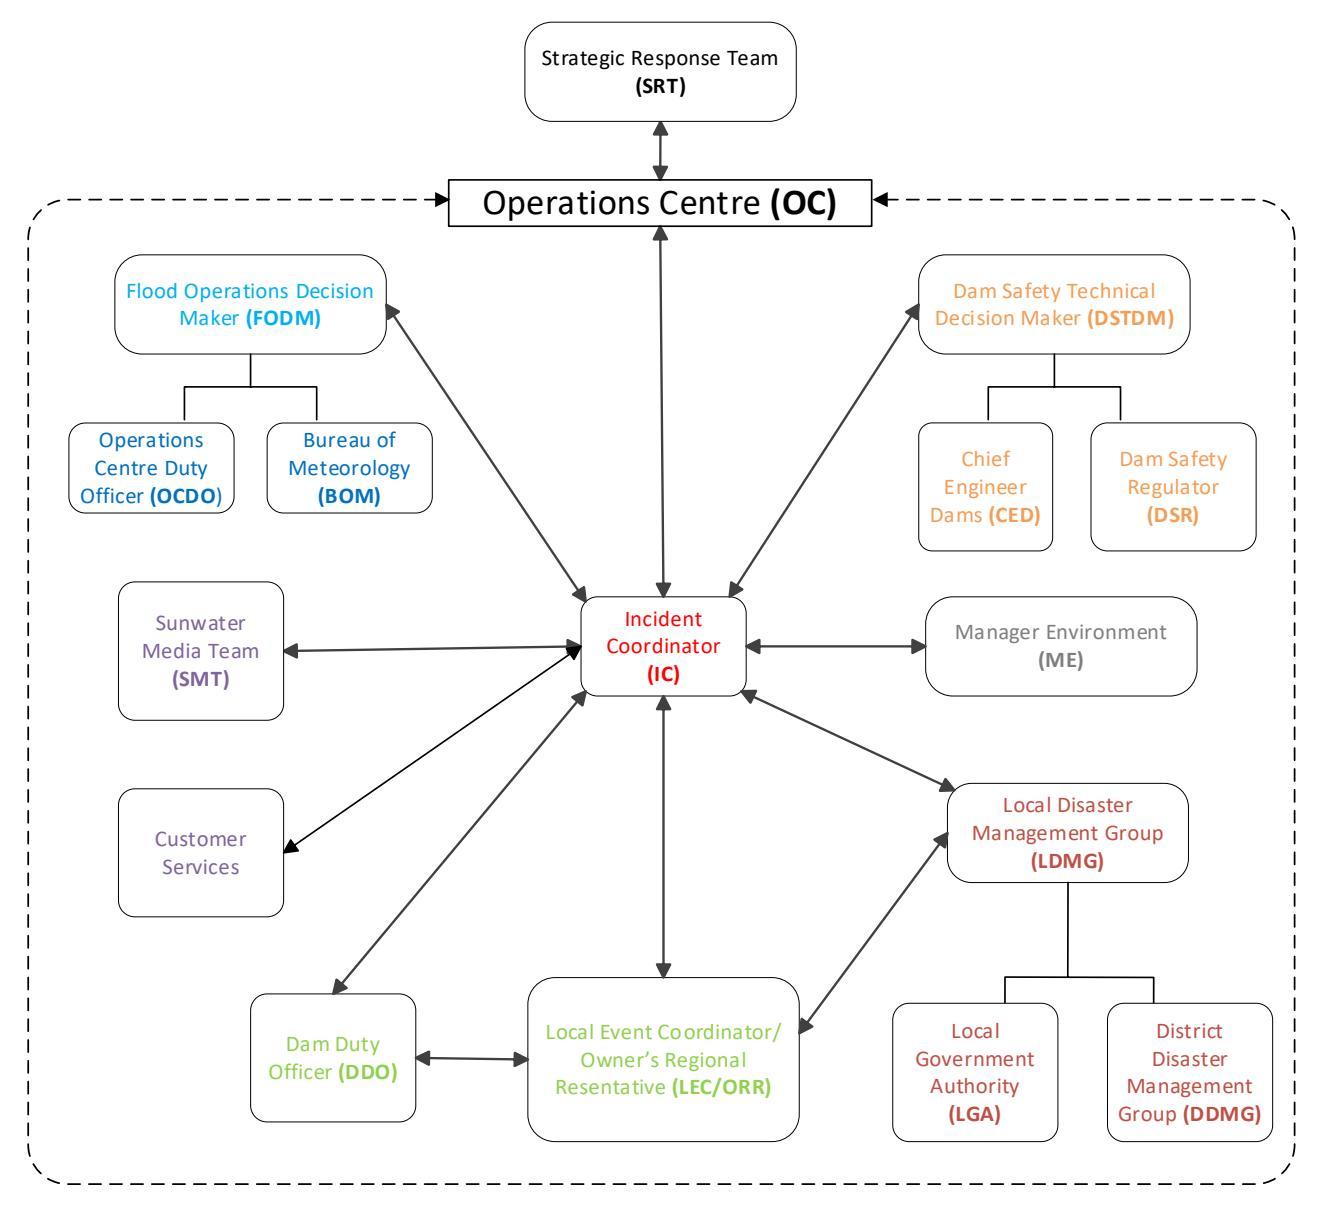
Figure 1: Sunwater dam hazard management framework

The Sunwater dam hazard management framework is illustrated in Figure 1 below.

Key aspects of the emergency management framework are described below:

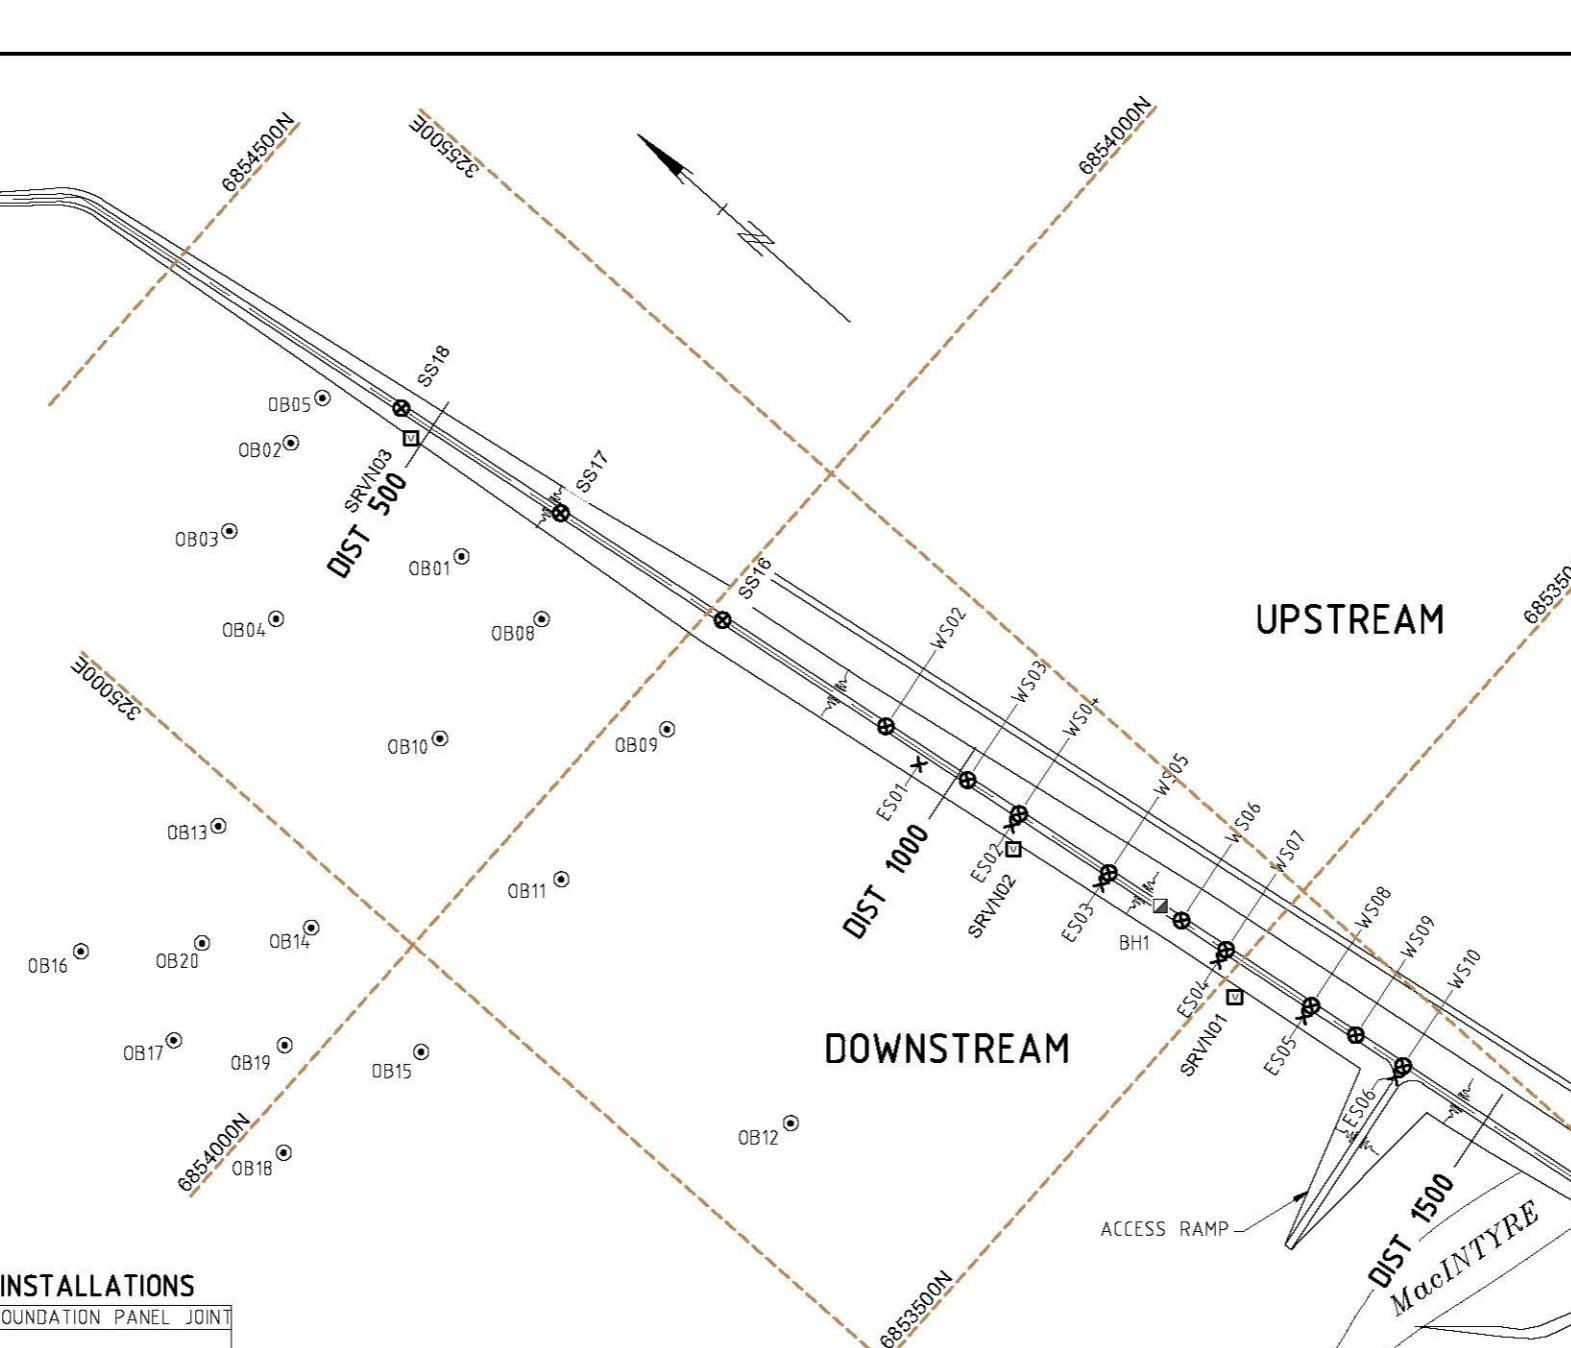
BOREHOLE PIEZOMETER EASTING NORTHING ELEVATION 325416 6853577 BH1

Let 1 1		122410	0000000	
	PIEZO 1 TIP			308.82
	PIEZO 2 TIP]		298.82
	PIEZO 3 TIP		-	288.82
BH2		325379	6852884	
	PIEZO 1 TIP			311.85
	PIEZO 2 TIP	1		308.35
	PIEZO 3 TIP]		303.35

WATER LEVEL & ELECTRIC SETTLEMENT INSTALLATIONS

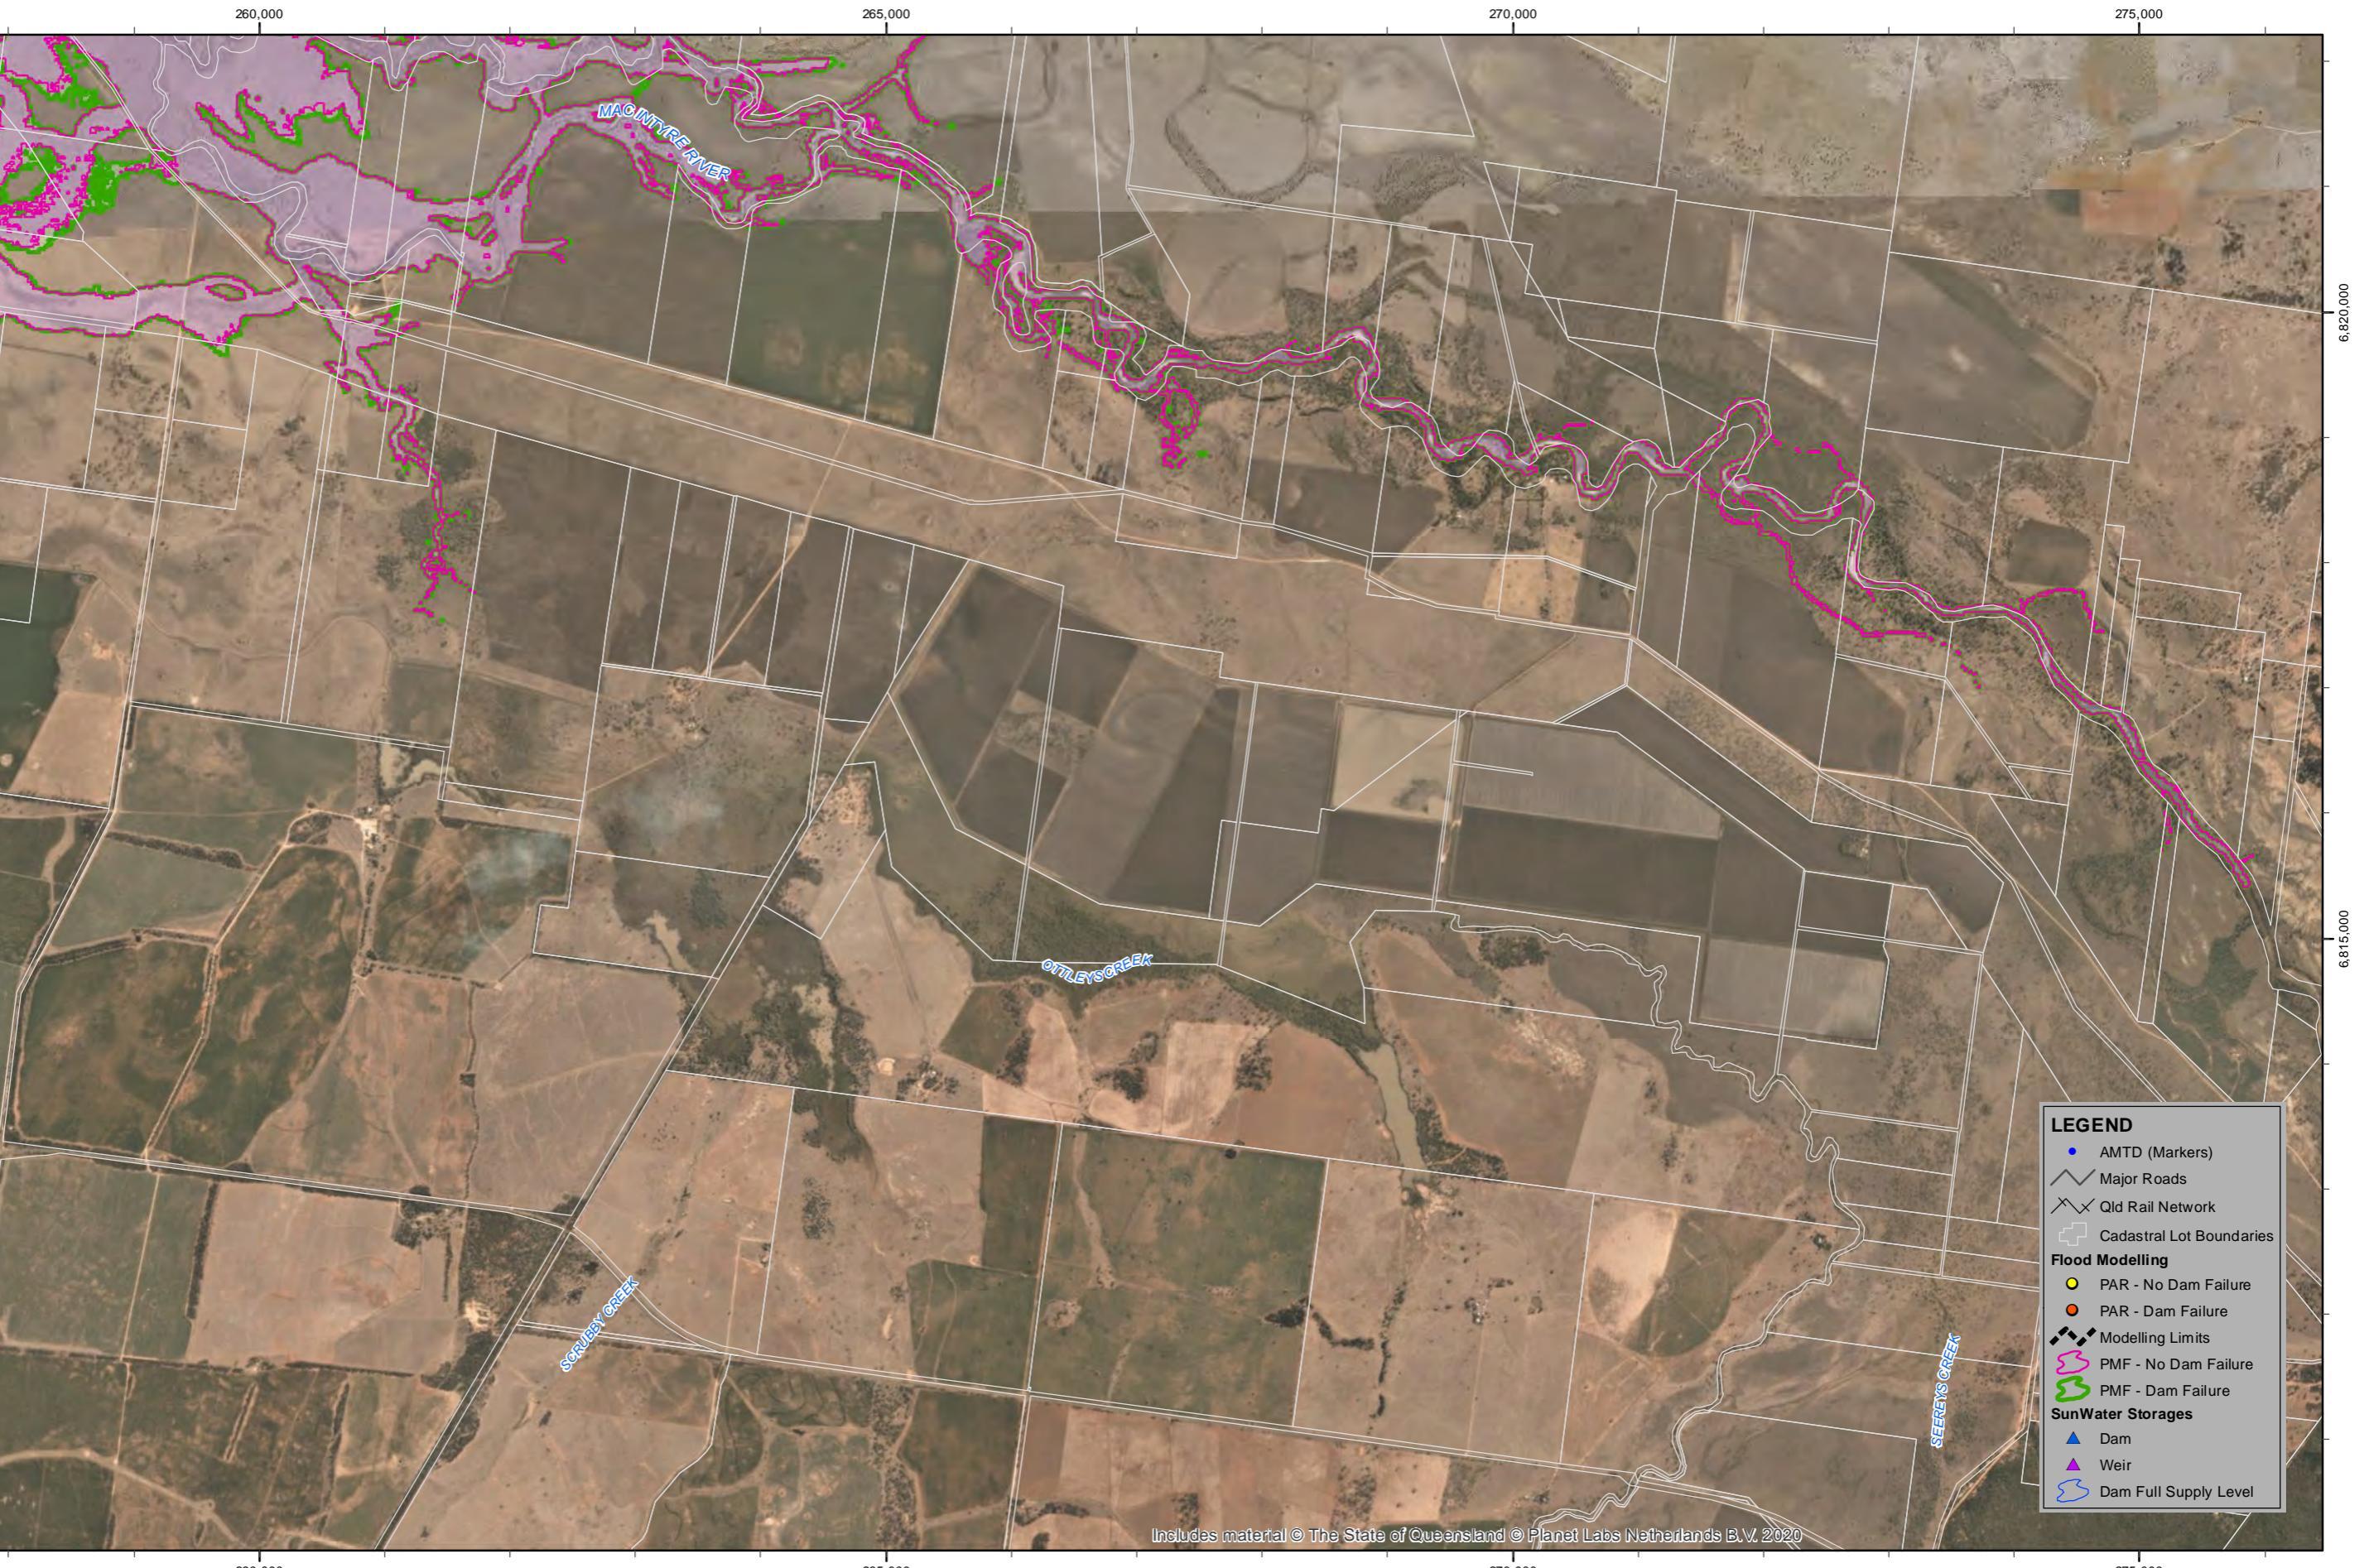
COOLMUNDA DAM DAM BREAK ANALYSIS 2022 PROBABLE MAXIMUM FLOOD **RIGHT EMBANKMENT AND FUSE PLUG** OVERTOPPING FAILURE INUNDATION PLAN

CONTRACT NUMBER DRAWING NUMBER REV. В 250825 SHEET 6 OF 15 DATE OCTOBER 2018 While every care is taken to ensure the accuracy of this product. SunWater makes no representations or warranties about its accuracy, reliability, completeness or subbility for any particular purpose and dischims all responsibility and all tability furculuting without limitation, itability in negligence) for all kepraiss, losses, losses, damages (including indirect or consequential damage) and costs which you might incur as a result of the product being inaccurate or incomplete in any way and for any reason.

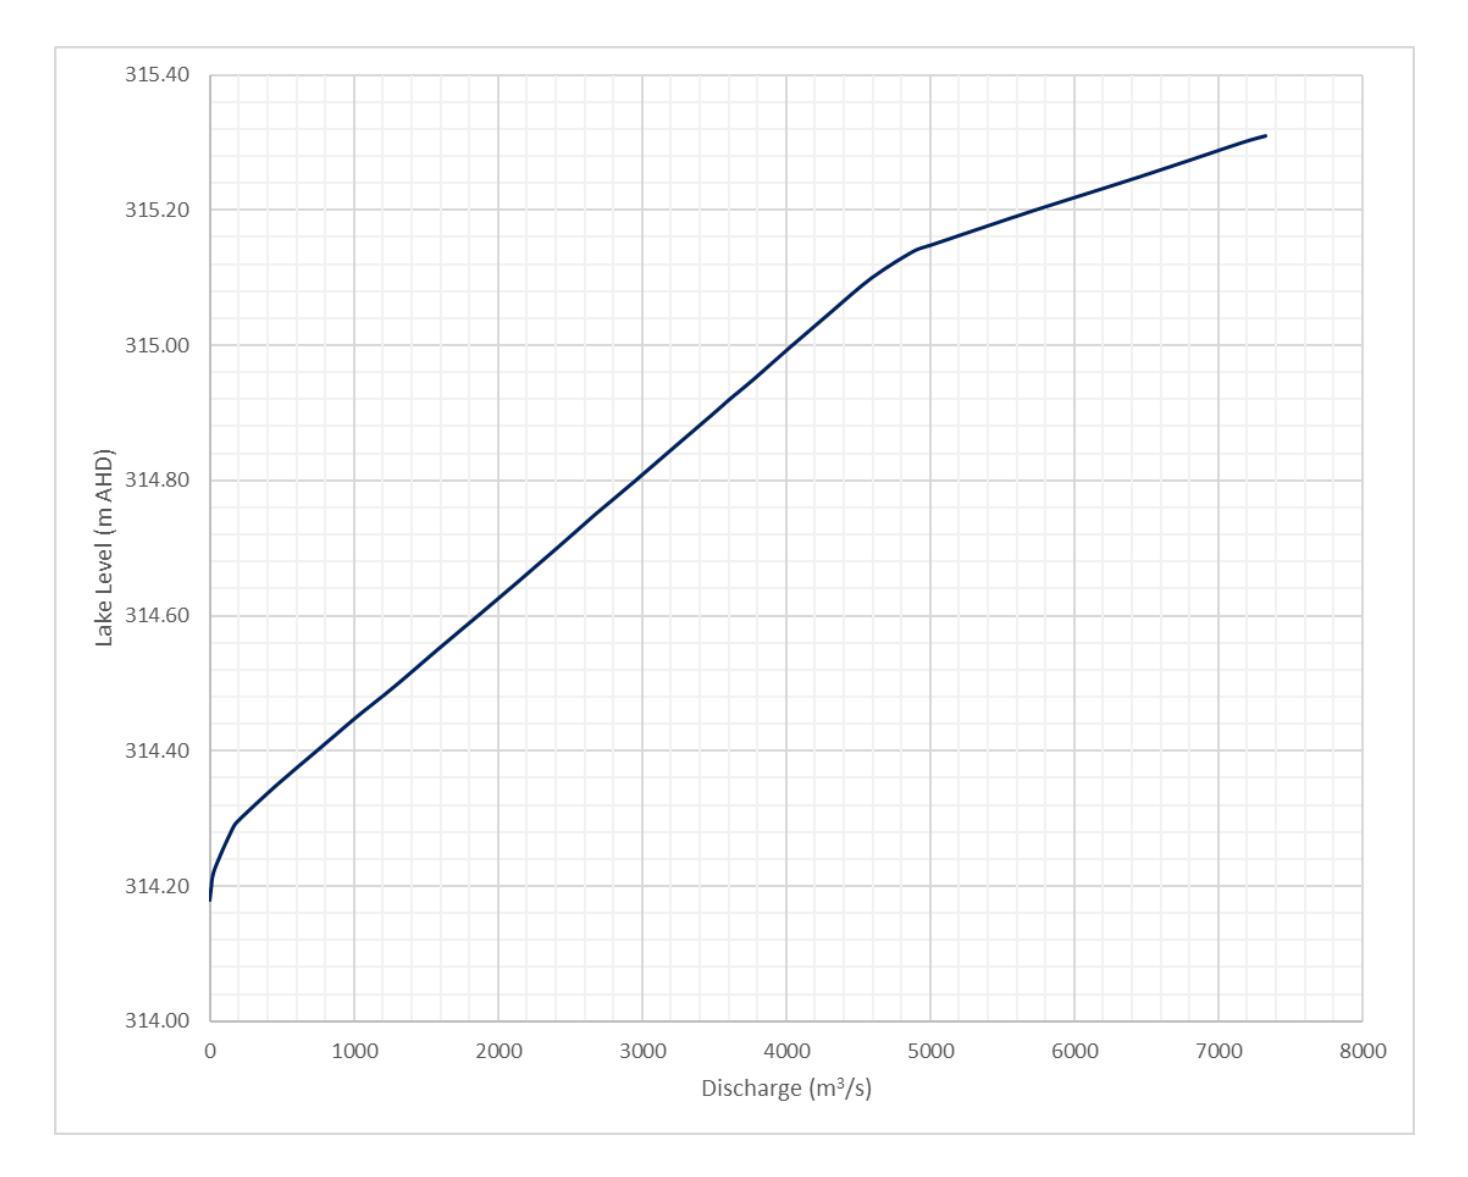
Figure C8: Coolmunda Dam spillway discharge rating curve

The figures on the next two pages have been extracted from the Coolmunda Discharge Rating Curve 2017 (ref P). The discharge estimates are for spillway flows only and do not account for flow through the fuse plug or over the embankment.

EAP		Lake				Radial	Gate Ope	ning (m)	·			Spillway Discharge
Phase	Key Levels	Level		Gate 4		Ga	ates 3 and	15	Gate	es 1,2,6 a	ind 7	(m ³ /s)
1 nuoc		(m AHD)	Acceptable Minimum	Automatic Design	Acceptable Maximum	Acceptable Minimum	Automatic Design	Acceptable Maximum	Acceptable Minimum	Automatic Design	Acceptable Maximum	Automatic Design
	Full Supply Level	314.07	closed	closed	closed	closed	closed	closed	closed	closed	closed	0
