Rookwood Weir

White-throated Snapping Turtle Nest **Protection Plan RWW-GHD-ENV-PM-002**

Sunwater Limited

1 December 2023

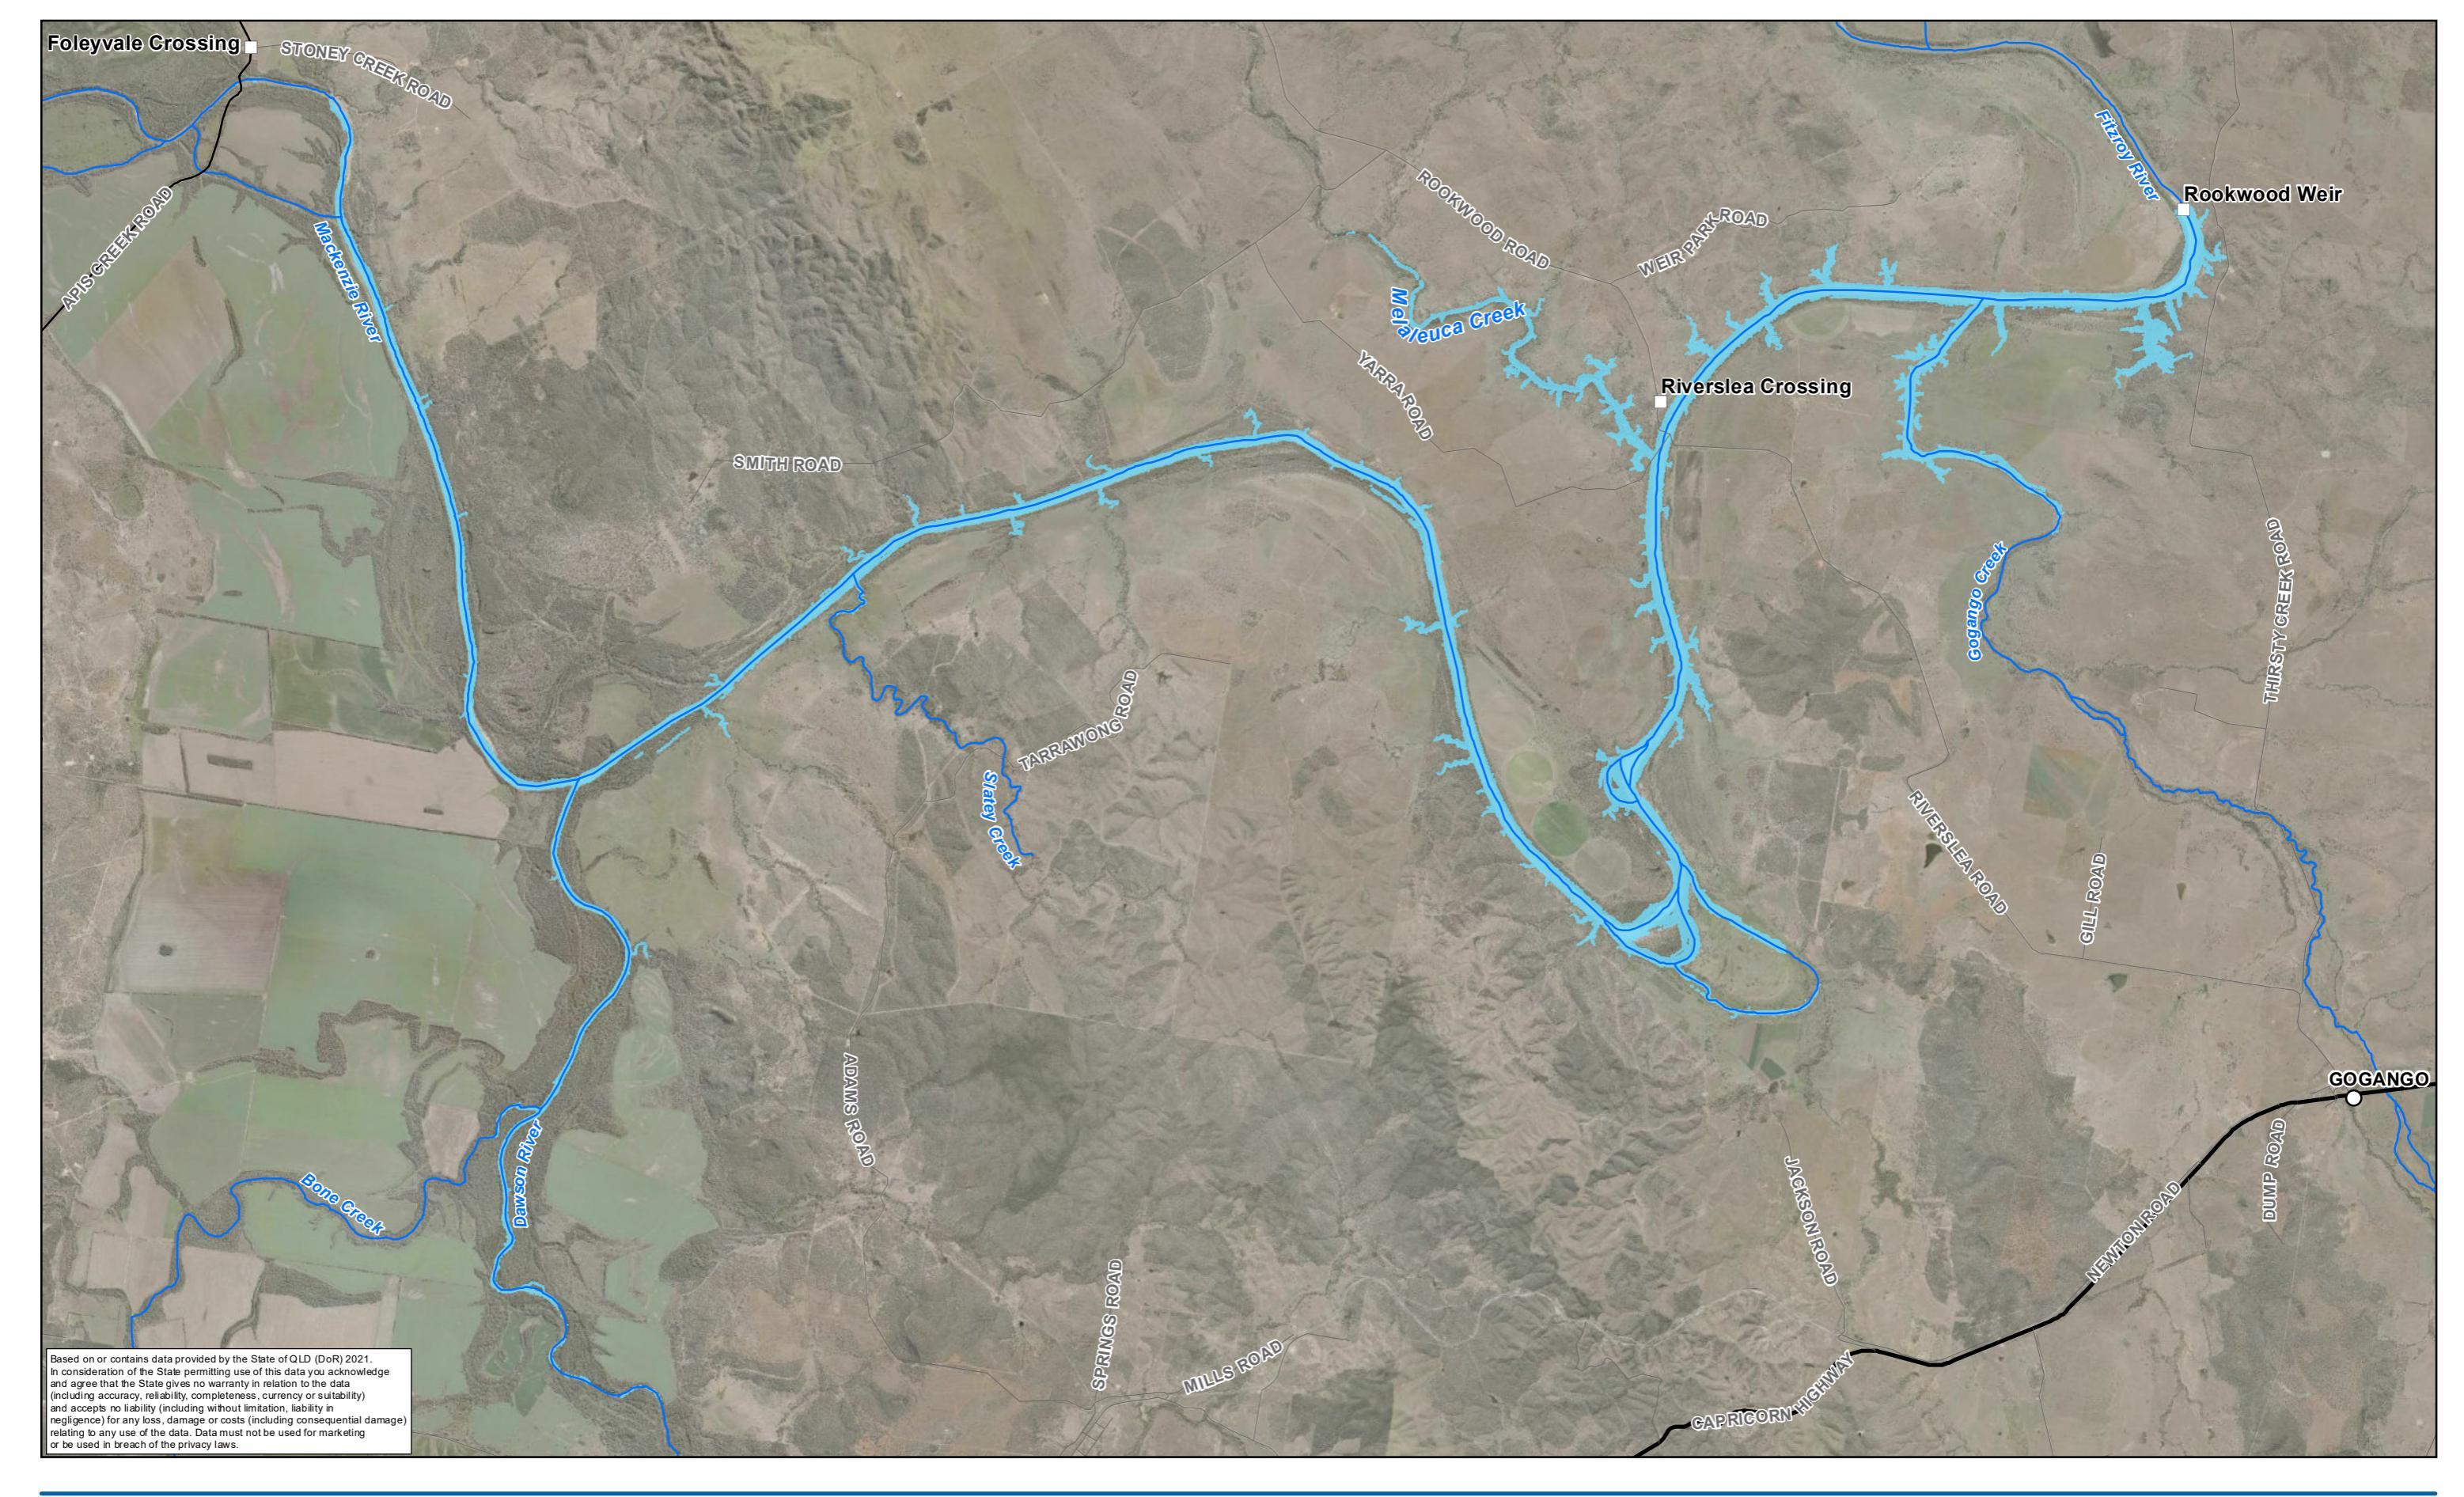
Inundation Area

Figure 1 shows the location of Rookwood Weir and inundation area extent which extends 323.3 km AMTD up the Mackenzie River and 10.3 km AMTD up the Dawson River.

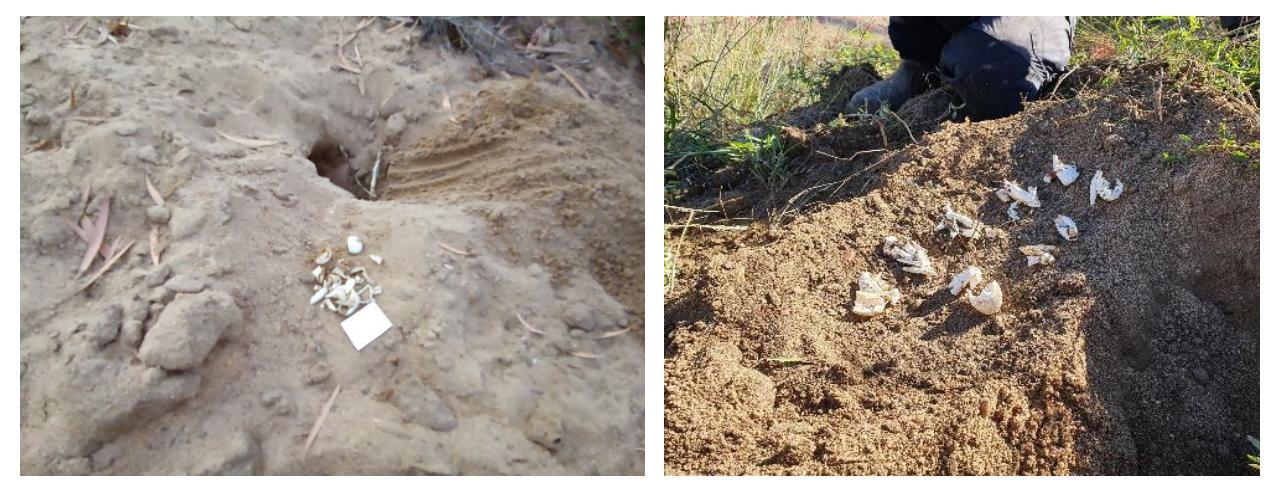
Figure 3 Predated nests

However, predation rates were very high with 100% nest predation recorded in 2019 and 92% in 2020 (Figure 3). In 2021, 21 intact nests (8.5 % of the 247 nests recorded in 2021) were identified within 24 hours of being laid and nest protection mesh applied (Figure 4), only one nest was found to have naturally hatched in 2021 (99.6% predation rate; Figure 5). Over the course of the three years of preclearance survey, a total of 11 turtle nests were observed to have hatched without nest protection, leading to an overall nesting success rate off 2.7%.

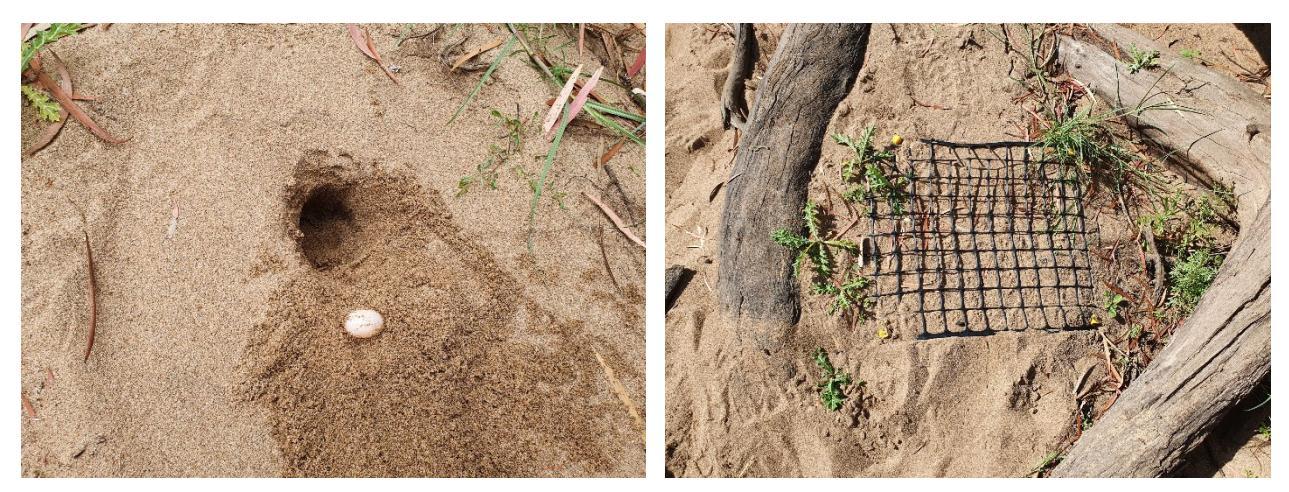
Figure 4 Intact turtle nesting – Upper Inundation area 9 (UI9) with nest protection mesh fitted (August 2021)

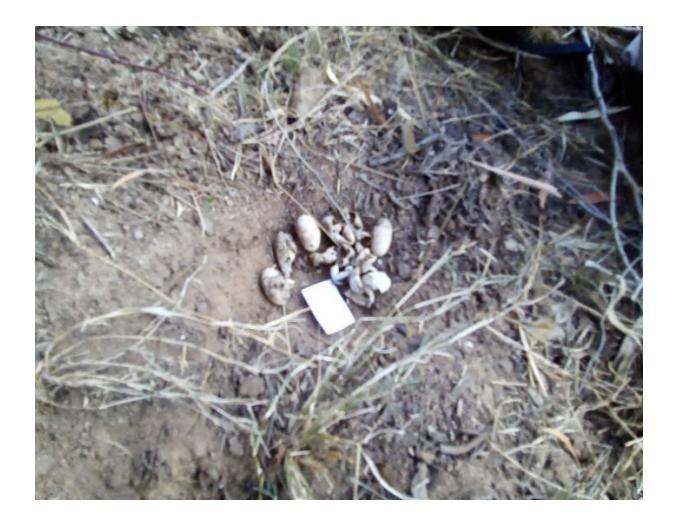
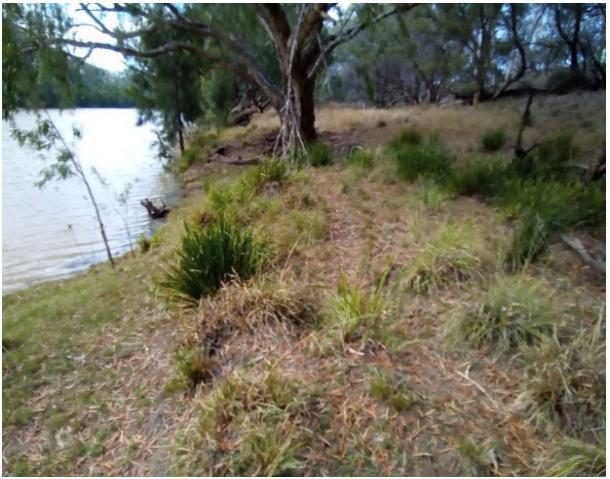
Figure 5 Hatched nest – The Pocket – P3– and nesting habitat (October 2021)

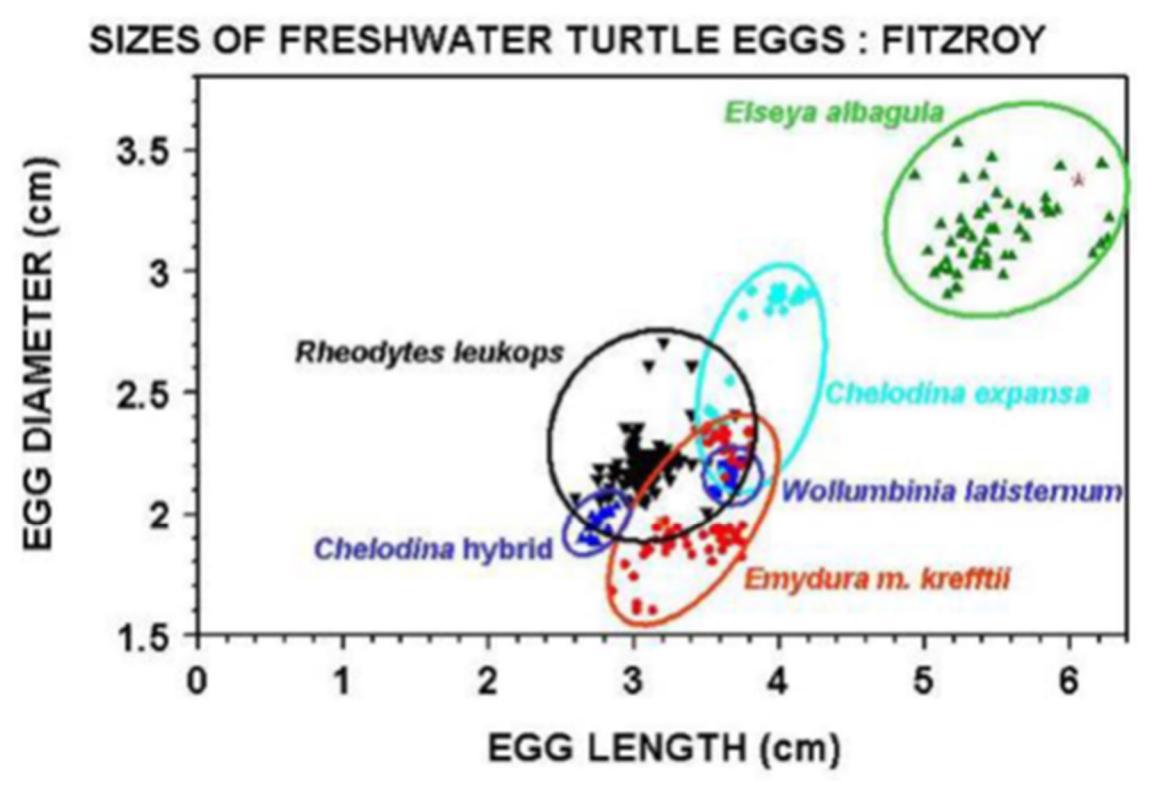
Figure 6 Freshwater river turtle egg size chart (Limpus et al. 2011)
