Paradise Dam

Fact Sheet: Anchor Trials Results

August 2021

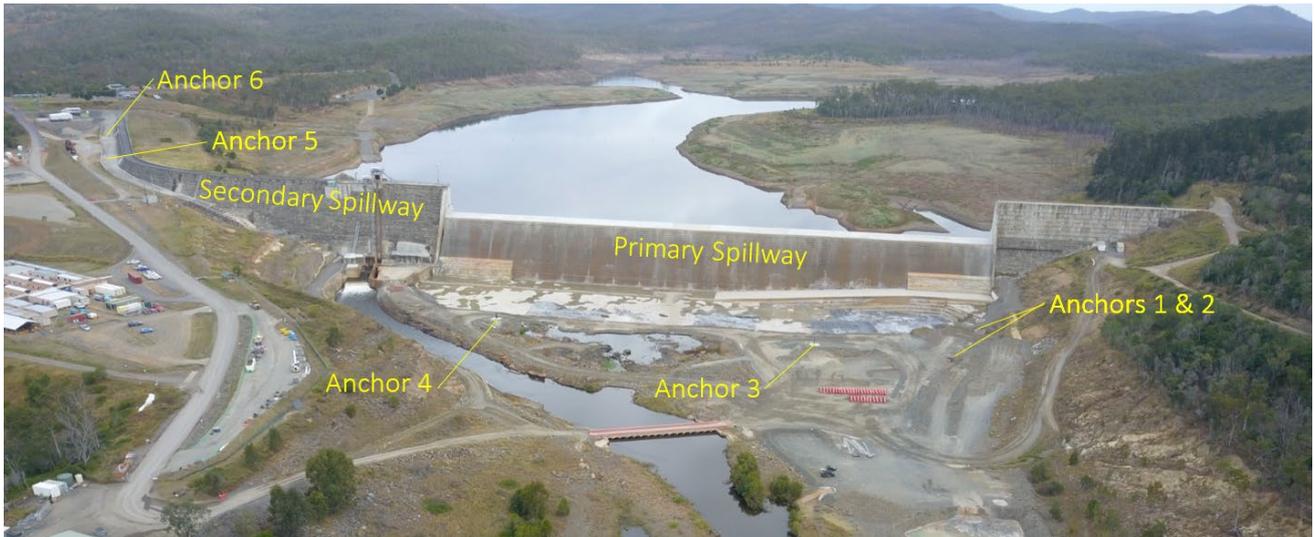
Figure 1 – Anchor trial locations at Paradise Dam.

Full-size trial anchors were installed at six locations downstream of Paradise Dam as shown in Figure 1. The locations were selected to represent the varying ground conditions that are expected below the dam foundation.

Four anchors were made up of 91 strands of steel cable, and two anchors were made up of 35 strands. The 91 strand anchors (anchors 1-4) were installed downstream of the primary spillway, with the bond zone of each anchor targeted for particular foundation material.

The 35 strand anchors (anchors 5 and 6) were installed downstream of the secondary spillway, with the intent to test both the bond zone and the potential settlement of the foundation material. Each anchor was installed within a vertical borehole (refer to Figure 3) and the bottom locked into place with cement grout.

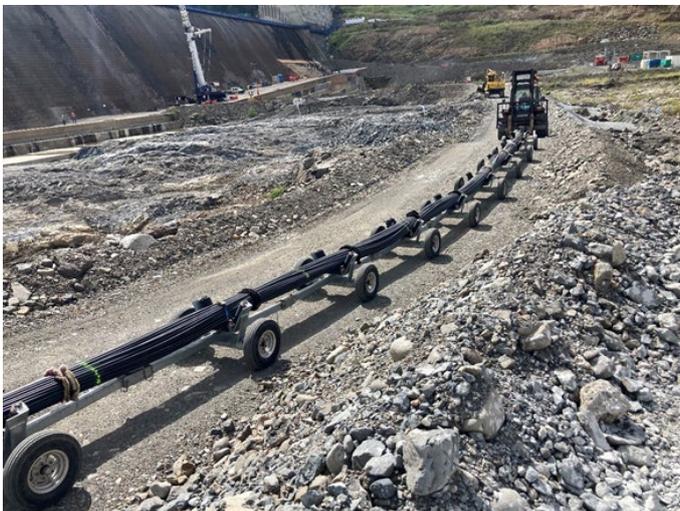
Figure 2 – Transporting a post-tensioned anchor from the fabrication yard to installation site.

The anchors are bespoke, and each was fabricated onsite then transported (refer to Figure 2), installed and tested by specialist contractor, SRG Global.

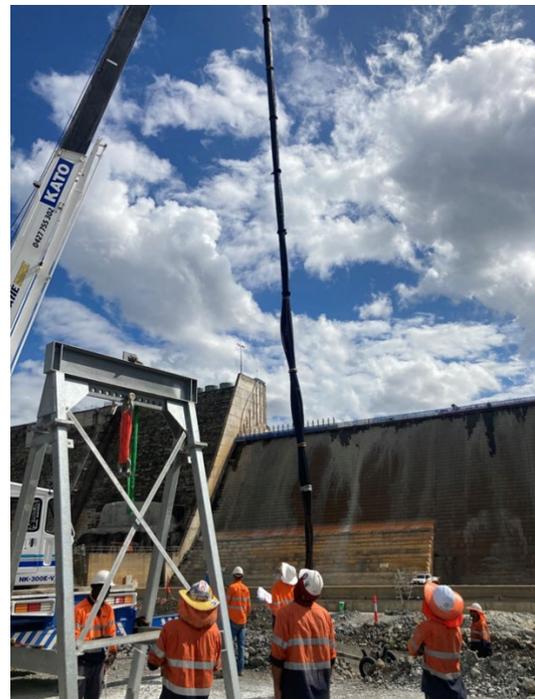
Figure 3 – Lifting anchor to lower into vertical borehole.

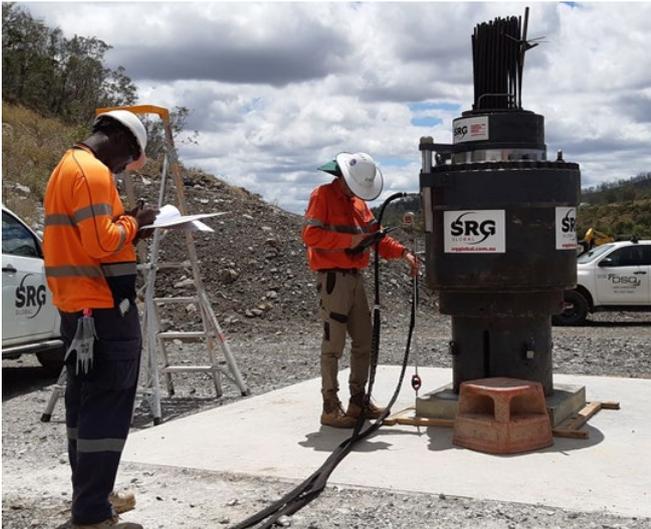
Figure 4 – A 2200 tonne hydraulic jack stressing a 91 strand anchor.

The anchors were tested using a large 2200 tonne capacity hydraulic jack and monitored for any loss in tension that occurred over time. The jack was placed on a reinforced concrete block, connected to the anchor, and the strands were then pulled to tension the cables (refer to Figure 4). Each anchor was then tested through a series of load cycles, including loads beyond those that would be applied if they were to be installed in the dam to help strengthen and stabilise it.

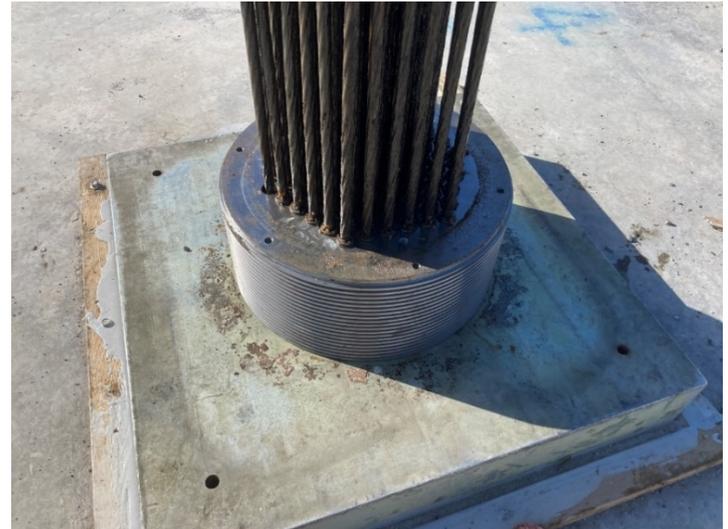
Figure 5 – Locked-off anchor following stressing.

Anchors that did not fail during the load cycle process were “locked off” into the anchor head block via the strand wedges, leaving the anchor in tension and effectively pulling the concrete block into the ground (refer to Figure 5). A 28-day lift off test was then undertaken to document any change in load and loss of tension.
